NOT SO QUICK ON THE DISCONNECT

CHECK FOR CRACKED CAPS

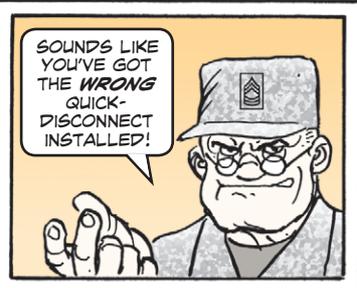
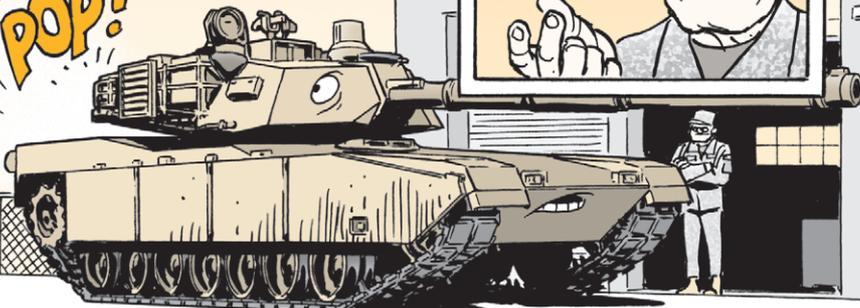
THERE GOES MY CASE DRAIN LINE QUICK-DISCONNECT AGAIN!

The case drain line sits back in a corner, so if you still have an old QD, NSN 4730-01-081-2106, installed, things can be a little tricky. Those old QDs may seem to be securely attached only to pop loose later. And a loose connection increases the chance of an engine fire and increases hydraulic pressure and temperature that could ruin the hydraulic pump.

That problem has been fixed with a replacement QD, NSN 4730-01-509-1330. This "sure lock" QD provides a one-way only connect feature that ensures a positive lock.

If you're having trouble keeping the case drain line QD connected, it could be that your tank still has the old one installed. If your QD is orange in color, it's the old one. Get your mechanic to change out the old unserviceable QD at the next scheduled service or when the powerpack is pulled for non-scheduled maintenance.

The new QD will be a dark color and have two notches at the opening end.

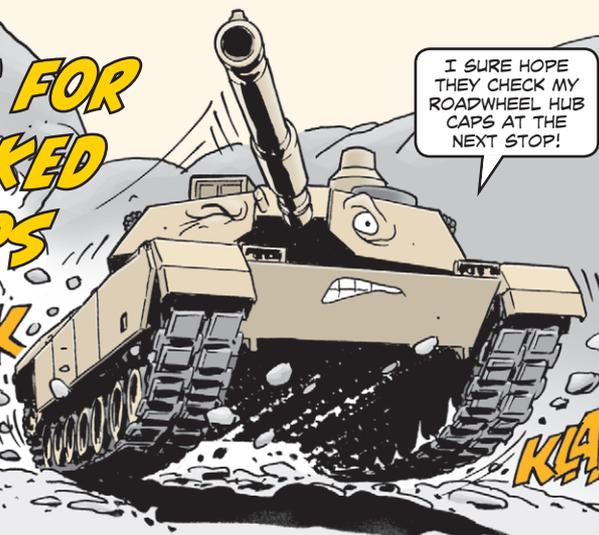
Crewmen, the tracks on your M1-series tank throw up a lot of rocks and debris during cross-country operation. It only takes one thrown at the right angle and speed to put a crack in one of the plastic roadwheel hub caps.

Oil leaks out of the cap and eventually the hub bearings seize up. That's an expensive and time-consuming repair.

You can help prevent that problem by checking the hub caps frequently during stops. If you notice an oil leak, tell your mechanic.

He'll install a new cap, NSN 2530-01-063-5862, and torque it to 40-60 lb-ft like it says in the -20-1-4 TMs.
