# TOO TIGHT IS TOO MUCH

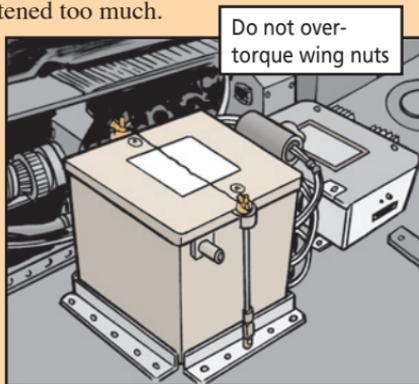
New mechanics and not-so-new mechanics, one extra twist to the wing nuts on the holddowns for the sealed lead-acid battery (SLAB), NSN 6140-01-286-6294, and you might hear a crack. That's the sound of the battery snapping.

Hand tight on the wing nut is tight enough. The battery tabs are not that sturdy, so they crack easily when the wing nut is tightened too much.

If you've already heard that sound, it means you've broken another battery locking tab. That makes the SLAB unserviceable.

Pay attention and follow the instructions on the battery's caution label. Don't work up a sweat when tightening the wing nuts. If you break a tab, you'll be replacing the SLAB battery at \$690 a pop.

Remember, for an unserviceable battery there is no 'wing and a prayer' solution—just replace it.
