# CORRECTING PROPERTY BOOK MISTAKES

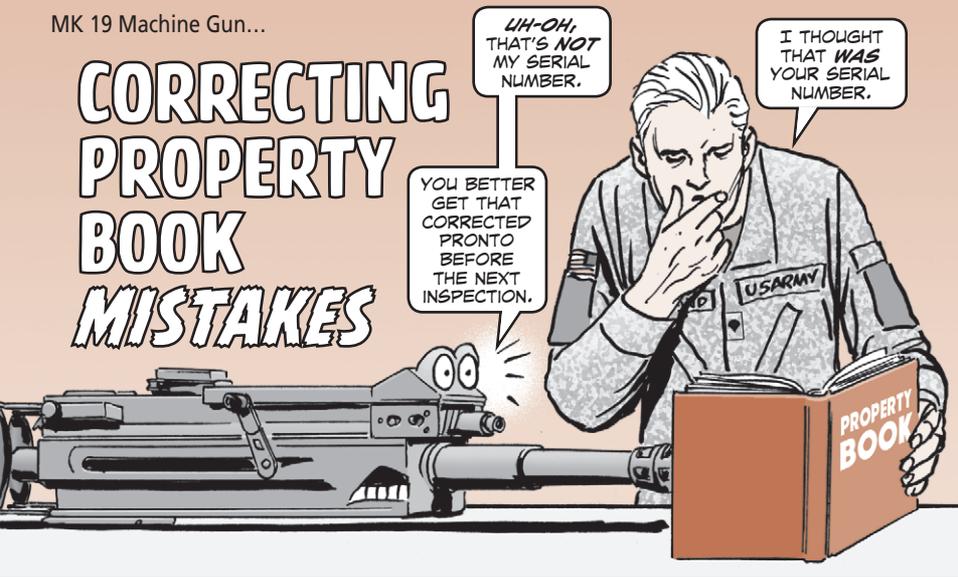
Almost half of the MK 19 machine gun serial numbers being recorded in property books or unique item tracking (UIT) are wrong. These property book mistakes will come back and bite armorers when it's time for inventory or turn-in.

The usual mistake is adding the date stamp or extra zeroes to the serial number.

Here's an example of how to correctly read the ID stamp on the left side of the receiver.
