FLAREBACKS CAN BE AVOIDED

THERE'S NOTHING THAT'LL RUIN YOUR DAY FASTER THAN A **FLAREBACK** IN YOUR M1-SERIES TANK.

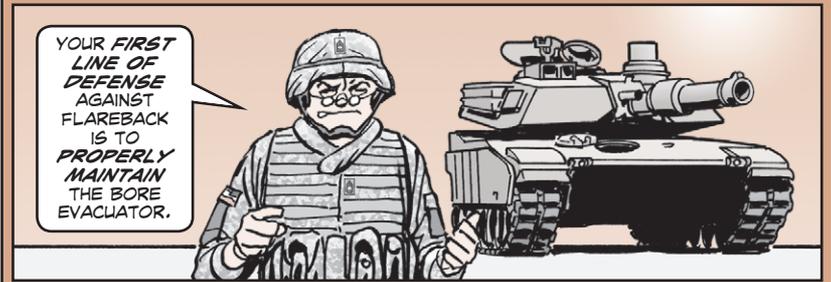
Maintenance

YOUR FIRST LINE OF DEFENSE AGAINST FLAREBACK IS TO PROPERLY MAINTAIN THE BORE EVACUATOR.

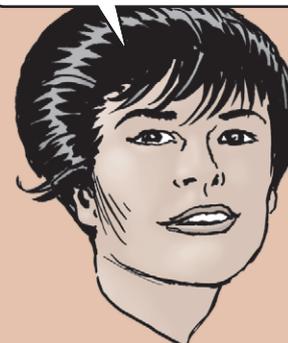
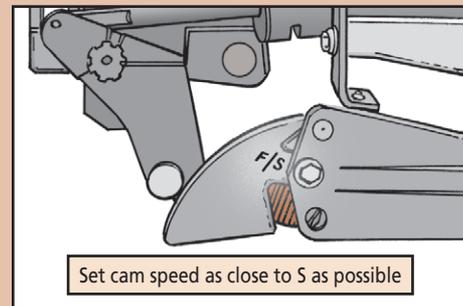
Cam Speed

THE BEST WAY TO REDUCE FLAREBACK DURING OPERATION IS TO SET THE OPERATING CAM SPEED TO THE 5 POSITION.

HOWEVER, IF THE CAM SETTING IS TOO SLOW, THE STUB BASE WON'T EJECT PROPERLY AND THE BORE EVACUATOR WILL START TO DISCHARGE BEFORE THE BREACH OPENS.

Instructions for setting the cam based on temperature and operating conditions start on Page 3-266 of TM 9-2350-264-10-2 (Mar 03), Page 3-160 of TM 9-2350-288-10-2 (Jul 95) and WP 0518 of TM 9-2350-388-10-3 (Feb 09).
