REPLACE THE 3-KW TQG MUFFLER HARDWARE

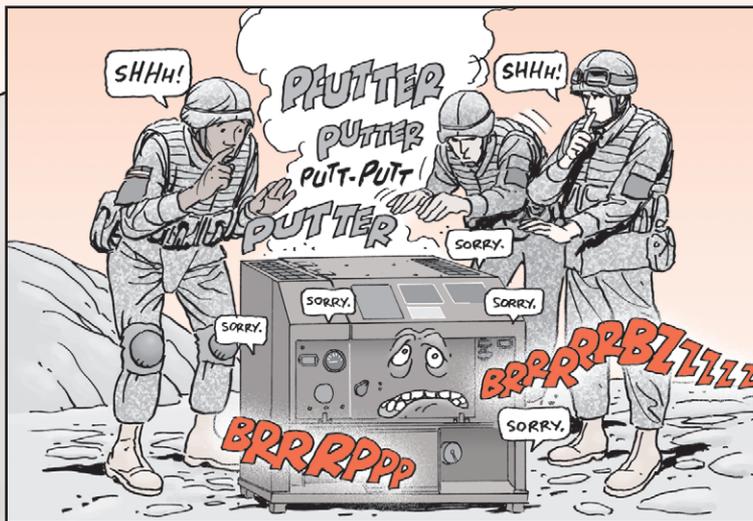
THAT NSN BRINGS AN 8MM BOLT WHEN YOU NEED A 6MM BOLT. SO, ORDER BOLT, NSN 5305-01-300-6266, INSTEAD. **THAT'S THE RIGHT BOLT FOR THE JOB!**

HOWEVER, WE TOLD YOU TO REPLACE THE CURRENT MUFFLER BRACKET MOUNTING CAP SCREWS—M6, 8.8—WITH CAP SCREWS—M6, 10.9—NSN 5305-01-303-5631... **THAT INFO IS BAD!**

PS IS NOT THE ONLY PUBLICATION THAT HAS THE WRONG BOLT LISTED. SO DOES YOUR TM.

CHANGE ITEM 16 ON PAGE C-103 IN TM 9-6115-639-13&P AND ITEM 7 ON PAGE C-9 BY DELETING THE CURRENT NSN AND ADDING THIS NEW ONE.

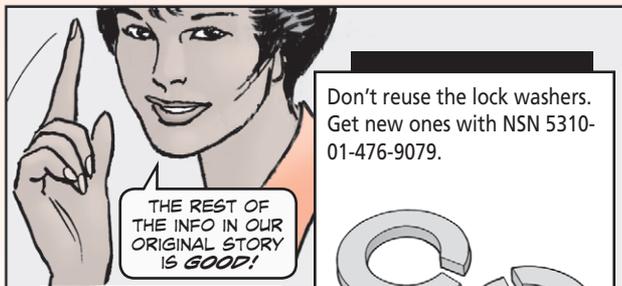
Replace the current muffler bracket mounting cap screws.

It could be that this job has already been done on your generator. Check the top of the cap screws. If the top has a raised W.T 10.9 and is yellow, you're good. If it has a raised FS 8.8 and is black, you're bad. Replace the hardware!

Don't reuse the lock washers. Get new ones with NSN 5310-01-476-9079.

Add a new flat washer, NSN 5310-01-566-5242, to each cap screw. These washers are black and thicker than the old yellow washers

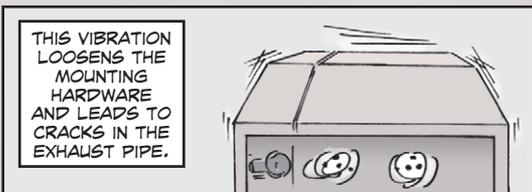
THE MUFFLER ON THE 3-KW TACTICAL QUIET GENERATOR TAKES QUITE A SHAKING WHILE THE GENERATOR IS RUNNING.

THIS VIBRATION LOOSENS THE MOUNTING HARDWARE AND LEADS TO CRACKS IN THE EXHAUST PIPE.

A CRACK IN THE PIPE OR MUFFLER CAN LEAD TO EXHAUST SYSTEM FAILURE, WHICH MEANS **MORE SMOKE AND NOISE.**

SO, ON PAGES 44-45 OF PS 676 WE RECOMMENDED USING STRONGER MUFFLER-MOUNTING HARDWARE.
