# COLD WEATHER CAN CAUSE LEAKS

**C**rewmen, if you're operating your M777A2 howitzer in very cold conditions, keep an eye on the suspension hydrostruts.

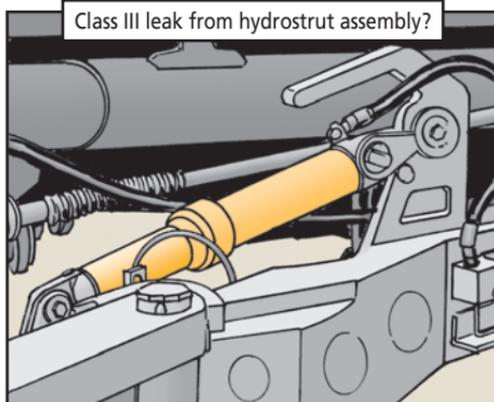
Units at Ft Wainwright, AK, noticed Class III leaks coming from the hydrostrut vent ports when they tried to raise howitzers that had been stored outdoors in temperatures below -10°F.

Turns out there's a slight problem between the hydraulic fluid and the hydrostrut piston seal, NSN 5330-99-679-8380. Over time, the seal loses its elasticity, especially in extremely cold weather. That can create leaks when the thermometer takes a nose dive.

If you notice a Class III leak at the hydrostrut vent valve, stop trying to raise the howitzer immediately. Lower the howitzer to the ground using the suspension levers and take the following action:

1. Deploy the wheel arm assemblies into the raised position, like it says on Page 2-124 of TM 9-1025-215-10 (Jun 06 w/Ch 3, Jul 08).
2. Return the wheel arm assemblies to the towing position (Page 2-175).
3. Try to build pressure with the suspension pumps, then relieve the pressure using the suspension levers.

Repeat these steps several times. That should energize the seals and help stop the hydraulic fluid leak. Once you're finished, make sure you check the suspension oil fluid level. If it's low, notify your mechanic.
