M109A6
Paladin...

Rifle Bracket Interference?

Stryker...

STEP LIGHTLY AROUND RESERVOIR

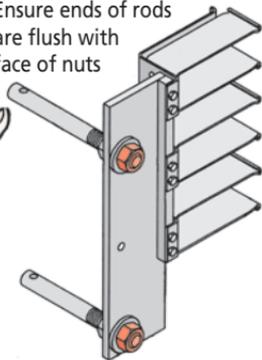
MWO 9-2350-314-30-5 REPLACED THE SHAFT FOR THE M109A6 PALADIN'S M16 RIFLE/M4 CARBINE BRACKETS. UNFORTUNATELY, SOME OF THE SHAFT NUTS WERE SCREWED DOWN TOO FAR.

AS A RESULT, THE SHAFT IS NOT FLUSH WITH THE NUT AND IT INTERFERES WITH THE EXCALIBUR ROUNDS IN THEIR RACKS.

Ensure ends of rods are flush with face of nuts

CHECK THE SHAFTS IN YOUR PALADIN. IF A SHAFT IS NOT FLUSH WITH THE NUT, CONTACT YOUR LOCAL TACOM ARMAMENT LAR FOR ASSISTANCE.
