HMMWV...

# OIL COOLER FAILURE DEAD-LINES TRUCK!

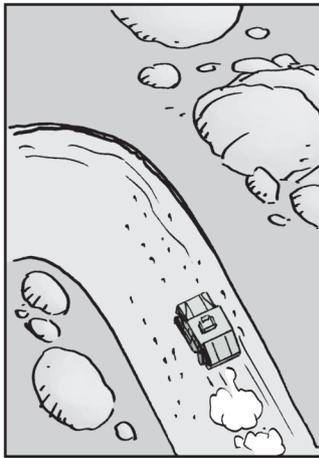
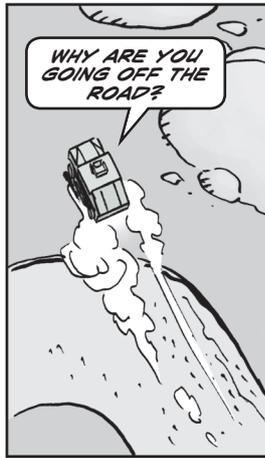
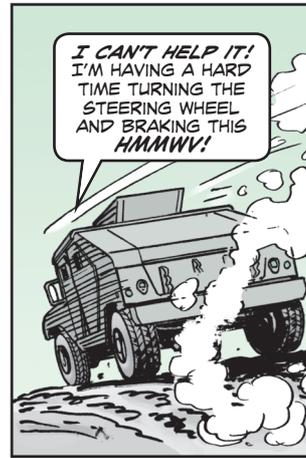
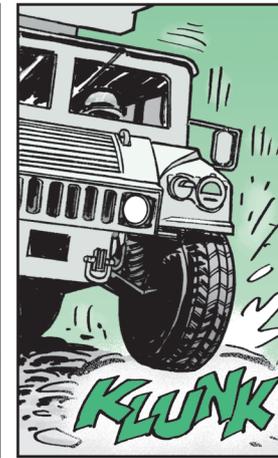
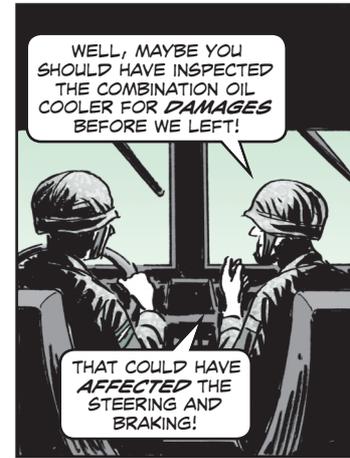
**D**oes your unit have HMMWVs with serial number 300,000 or higher? If so, your HMMWV could have a faulty combination oil cooler.

The combination oil cooler contains engine oil, transmission oil and power steering fluids. Problems with the power steering oil cooler segments have been reported to TACOM LCMC. The power steering fluid flow tubes are located within the center section of the combination oil cooler.

These tubes could expand or rupture during initial engine warm-up or start-up, especially when the vehicle's hydraulic system is cold. A ruptured power steering cooler causes a loss of power steering fluid and pressure, making your HMMWV hard to steer. Braking will also suffer because the power hydro-boost is also affected. You don't need hard steering or braking, especially in a war zone!

Avoid this by inspecting the combination oil cooler for ruptures, leaks or swollen tubes like the PMCS table in TM 9-2320-387-10 says. Here's a quick reminder, as it relates to the oil cooler:

If you find a faulty oil cooler, your HMMWV is NMC! And it'll stay that way until the combination oil cooler is replaced. By the way, an oil cooler relief valve retrofit kit has been developed to prevent premature failure of the combination oil cooler. But your HMMWV isn't NMC if this retrofit kit is not installed.
