# Loose Cable Like a DAGR in the Back

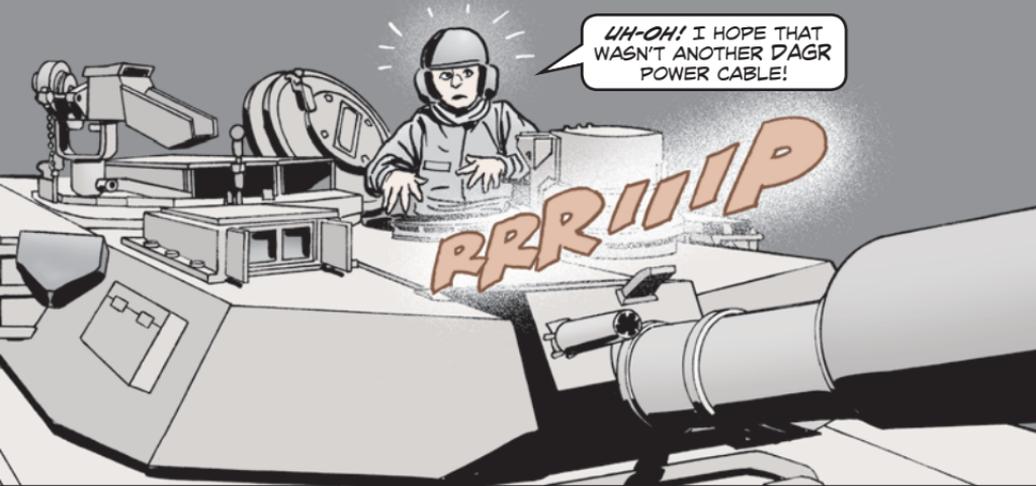
**S**pace is always tight when you enter and exit a tank. But it can be **exceptionally** tight when moving through the loader's hatch on your M1A2 SEP tank.

Problem is, that darn 1W106A-7 DAGR power cable, NSN 6150-01-557-4006, keeps getting in the way, especially if you're wearing body armor. Once snagged, the cable gets jerked loose or damaged. Then you lose power to the DAGR.

When installing the DAGR, make sure the power cable is fitted into its storage slots. Then use some plastic wire ties, like NSN 5975-00-111-3208, to hold any drooping cable out of the way.
