Get New Decal for Straight Scoop

FM 3-20.21 Note

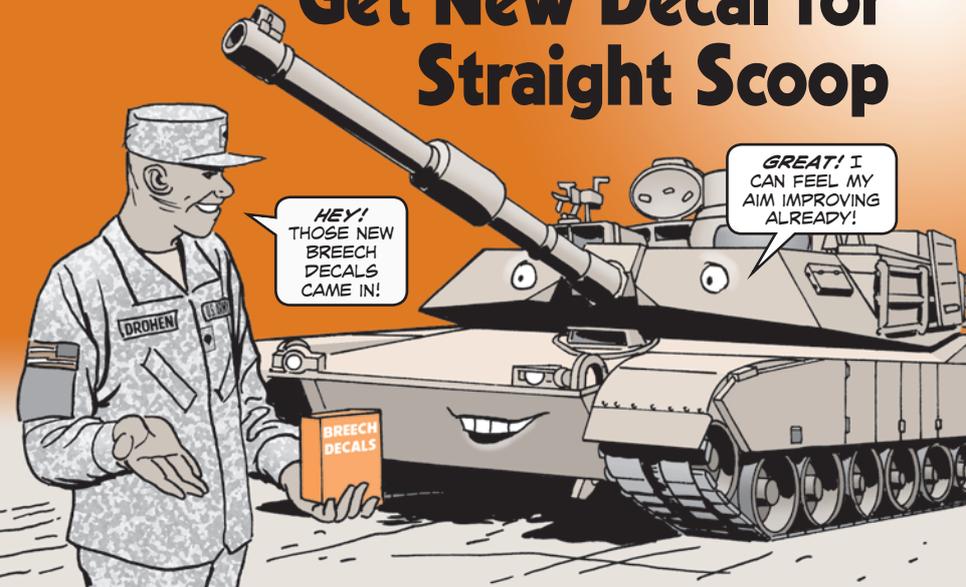
Step 3 on the decal says to read the **top of the coax ammo feed chute** against the scale on the gauge. Problem is, warping and bending of the ammo feed chute can result in a bad measurement. So the procedure has been amended to read the **top of the breech-ring** against the gauge instead.

The correct instructions are on Page 2-32 of TM 9-2350-264-20-2-1 (Apr 03) and WP 0258-22 of TM 9-2350-388-23-2-2 (Jan 09). But most mechanics just follow the decal and get a wrong reading.

A new decal, NSN 7690-01-575-0788, is now available with the correct instructions. So strip off the old decal and apply the new, stick-on label in its place.

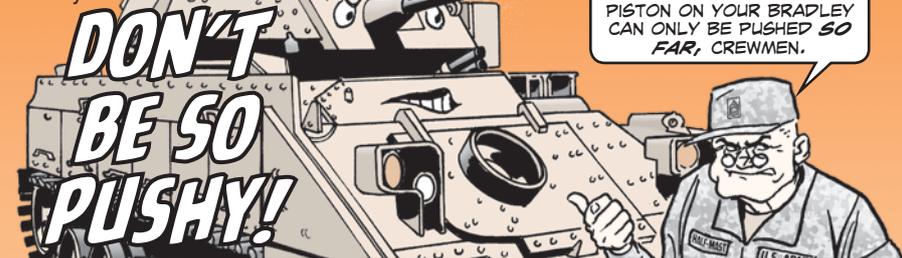
When tightening the track, the maximum extension for the piston is 3 ³/₄ inches. If you try to tighten any more than that, excess grease is bled off through a small hole in the piston. You're just wasting grease because the track won't get any tighter.

If you see grease coming out of the bleed hole and the track is still too loose, bleed off the track adjuster to loosen the track and remove a shoe. Then try again.
