# REAR SUSPENSION CRACKS SET YOU BACK!

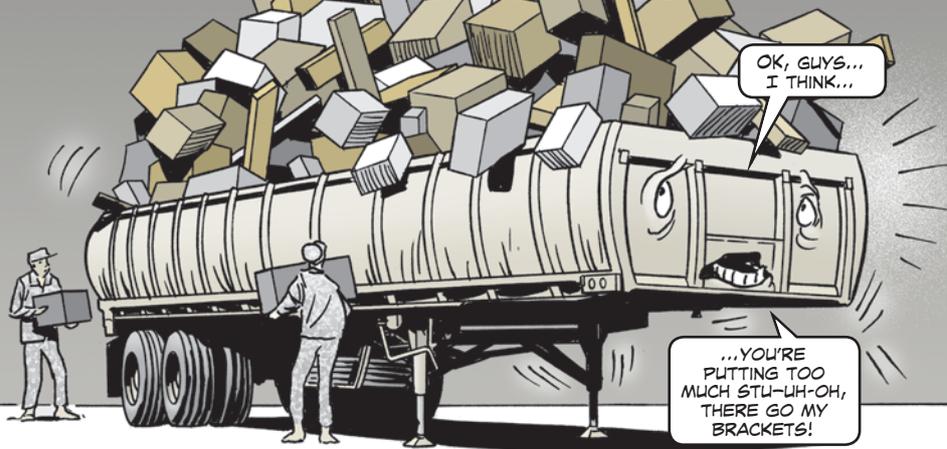
Did you know the maximum cargo load for M871 and M871A1 semitrailers is 45,000 pounds? If you overload, poorly distribute loads, or abuse those semitrailers in any way, they could crack under the pressure. And cracks or separations in your semitrailer's rear suspension system make your semitrailer *NMC!*

TACOM SOUM 10-017 told commanders to have all M871 and M871A1 semitrailer trunnion mount brackets inspected at the frame weld area for cracks and/or separations using TB 9-2510-242-40 as a guide. That's because cracks have been found in the trunnion mount bracket assembly area that attaches the suspension and the axle to the frame. In fact, the welds on some semitrailers are *completely* cracked, separating the trunnion from the frame. This could lead to complete separation of the rear suspension and axle from the semitrailer!

Don't repair cracks if you find them because the M871 & M871A1 semitrailers are on the automatic disposal list. Just turn your unserviceable semitrailers in to DLA Disposition Services (formerly called the Defense Reutilization and Marketing Office or DRMO). Then order a replacement, if authorized by your unit's TOE.
