REVISIT COMMUNICATION CORD PROBLEM

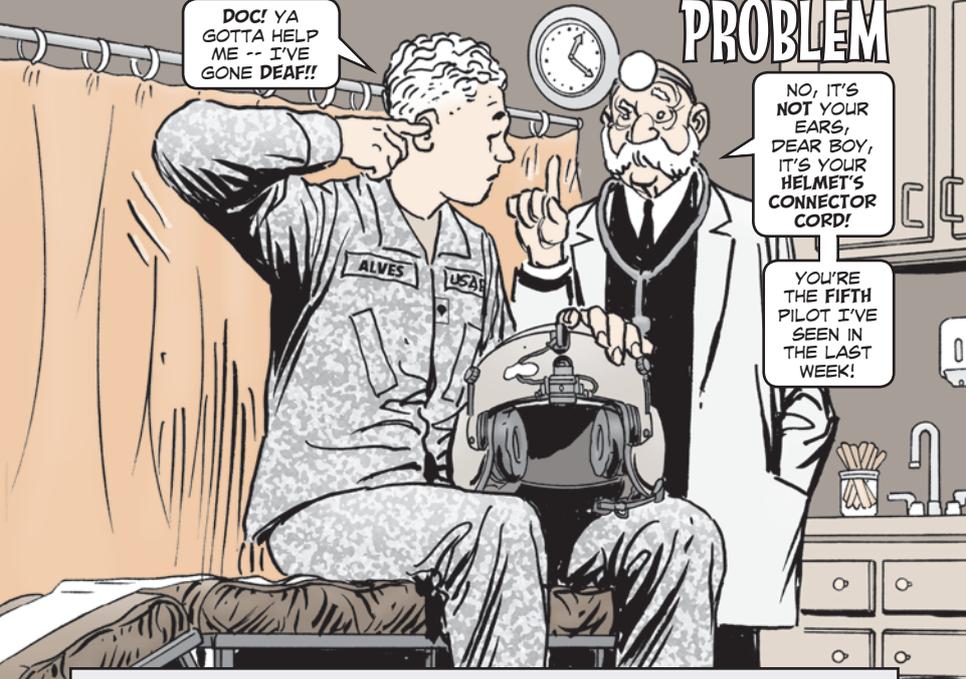
The information we gave you on Page 37 of PS 700 (Mar) was not quite correct concerning the communication earplugs (CEPs) and ordering the right integrated communication cords for the aircrew integrated helmet system (AIHS). The article didn't identify a new and separate problem that appeared with aftermarket communication cords.

So the question is, "what's the deal with the cords?" The information we gave you in the article dates back to 2007 and applies to the initial lot of communications cords provided by Gentex that had the CEP wiring branch integrated into the helmet's communication cord. Unfortunately, this first lot of cords had a manufacturer defect and some of them found their way into the supply system. There was no effective way to recall these cords, so Gentex offered a voluntary one-for-one replacement for any defective cords.

We forgot to tell you that there was a new problem with the communication cord that developed after the first lot. In 2008, DLA stopped purchasing the communication cords directly from Gentex and began to purchase cords directly from several aftermarket manufacturers whose CAGE codes are: 38LK9, 305Q5, and 7Z016. Units started submitting PQDRs against the aftermarket manufacturers in May of 2010. The problems with these aftermarket communications cords involve problems with loose and sloppy over-braiding, cold solder joints, and the failure to use parts called out on the drawing that can be seen in the picture below.

If your readers have any bad cords marked with cage code 38LK9, 305Q5, and 7Z016 in their ALSE shop, they should not send them back to Gentex. To get credit for any bad cords, they must submit a PQDR like it says in AR 702-7-1, *Reporting of Product Quality Deficiencies Within the U.S. Army*.

To order the correct electrical branched cord assembly for their helmets, they should use NSN 5995-01-519-9234 (P/N 1680-ALSE-410-1).

If a unit has problems with their helmet communication cord signal not reaching the CEP, they should follow the diagnostic procedures in the Air Warrior IETM, TM 1-1680-377-13&P.
