MRAP GUNNER'S HATCH LATCH PIN

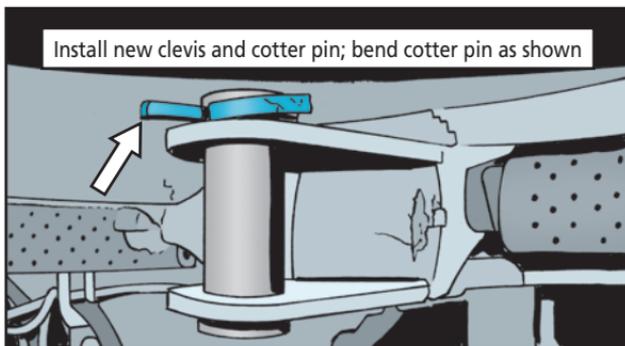
The gunner's sliding hatch inner lock assembly latch pin on the MRAP MaxxProPlus is falling out of place because of a faulty C-clip. That means the hatch can slam down without warning on the gunner! Refer to WP 4-14.4 of TM 9-2355-318-23-3 on how to remove the C-clip, Item 9, and the latch pin, Item 10, and how to replace them with retrofit latch and cotter pins. See TACOM GPA 09-020 for more info:
