BREECH SWABBING WARNING

AN INCIDENT
INVOLVING
ACCIDENTAL
PROPELLANT
IGNITION
DURING AN
M777A2
HOWITZER FIRE
MISSION HAS
RESULTED IN
SOME **CHANGES**
TO PARA 2-30
OF TM
9-1025-215-10
(MAY 10, W/CH
1, FEB 11).

M60A1 AVLB R&classification

THE MLC FOR
FULLY MISSION
CAPABLE BRIDGES
HAS CHANGED FROM
70 TO 85!

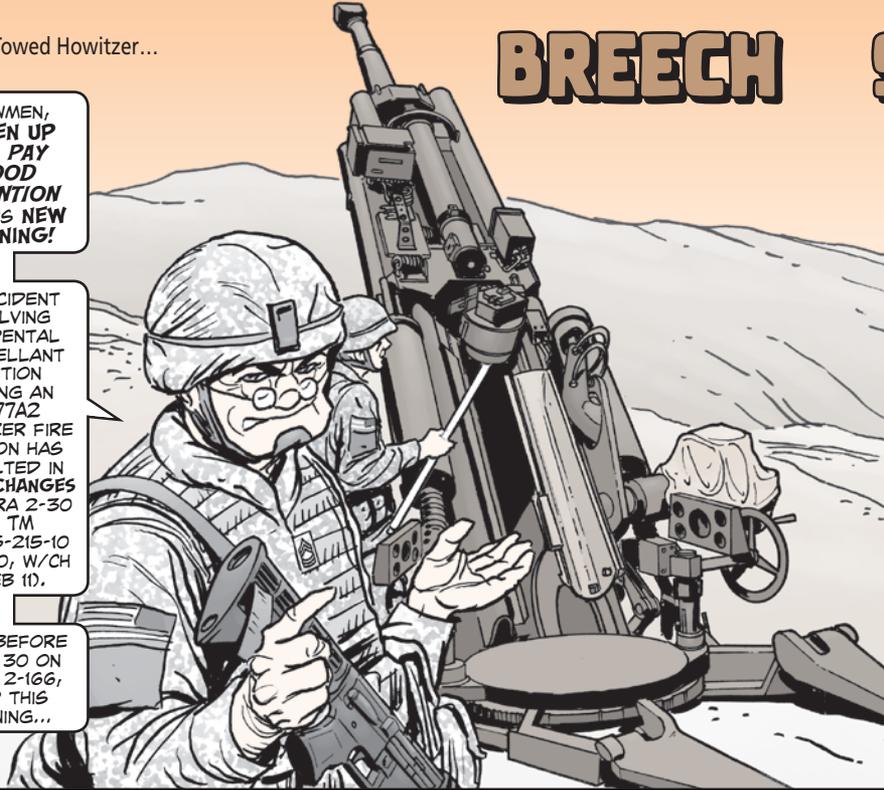
Crewman must swab the bore after each round fired to clear chamber of hot embers. Failure to swab the bore after each round fired may cause explosion or fire outside the breech area and cause injury or death to personnel and damage equipment.

Forgetting to swab bore after each round can ignite propellant and damage equipment

JUST BEFORE
STEP 30 ON
PAGE 2-166,
ADD THIS
WARNING...

1. Change Step 30 to: Cannoneer No. 2 swabs powder chamber, spindle assembly, and gas check seat using chamber swab (30) after each round fired.
2. Change Step 31 to: Driver inspects cannon tube (31) and will announce BORE CLEAR after the last round of the mission.
3. Delete Step 32.
4. Renumber Step 33 as Step 32.

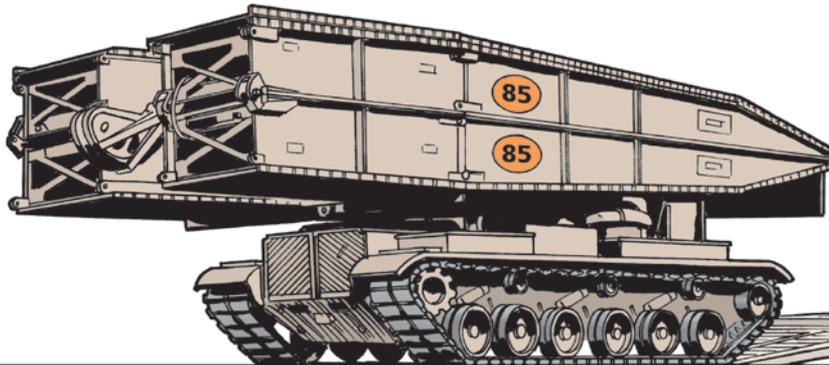
The military load classification (MLC) for the armored vehicle launched bridge (AVLB) has changed.

Follow the PMCS in TM 5-2420-203-24 to completely inspect the bridge. If the bridge is fully mission capable, you can change the stencil marking in four places on the side of the bridge from 70 to 85, and the numbers on the load-disk assemblies from 70 to 85.

The numbers on the load-disk are black, 5 inches tall and on a yellow background.
