# NOSECUP PARTS REVERSED

# Opening BAWs Manually

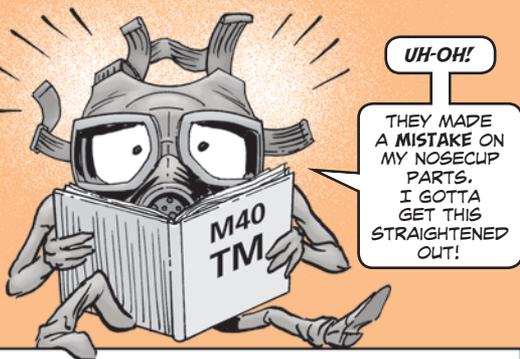
I noticed in the M40/M42 mask's TM 3-4240-346-23&P (Aug 10), the nosecup valve disk and the nosecup valve seat assembly are reversed in both Fig 2 and Fig 4 of WP 0031. The valve seat assembly is actually Item 2 in both figures and the valve disk is Item 3. I've submitted a DA Form 2028, but CBRN specialists might want to correct their TMs in the meantime.

Nosecup valve seat assembly is Item 2.  
Valve disk is Item 3

*Editor's note: Good eye, Master Sergeant. CBRN specialists, make a note of this correction to save yourself parts confusion.*

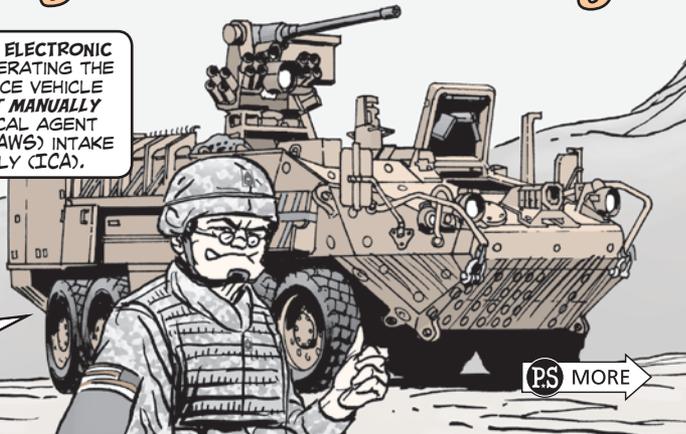
IF THERE IS A FAILED ELECTRONIC ACTUATOR WHILE OPERATING THE NBC RECONNAISSANCE VEHICLE (NBCRV), YOU **MUST MANUALLY OPEN** THE BIOLOGICAL AGENT WARNING SENSOR (BAWS) INTAKE CLOSURE ASSEMBLY (ICA).

UNFORTUNATELY, THE NBCRV'S TM DOESN'T EXPLAIN HOW. TURN THE PAGE TO FIND OUT!

- Disconnect the BAWs ICA power cable from the harness guard connector.
- Put the protective cap on the connector.
- Use a cross-tip screwdriver and a 7/16 box-and-open-end wrench to remove the two nuts and screws from the BAWs ICA actuator.
- Remove the actuator from the BAWs ICA stack and put it in stowage.
- Reinstall the two screws and two nuts on the BAWs ICA stack.
- Pull down the sleeve of the stack until the stack is fully open.
- Continue the mission and notify field maintenance as soon as possible.

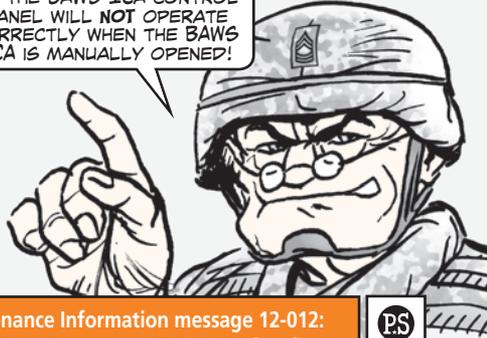
**NOTE: THE INDICATOR LAMPS ON THE BAWs ICA CONTROL PANEL WILL NOT OPERATE CORRECTLY WHEN THE BAWs ICA IS MANUALLY OPENED!**

For more info, check out TACOM Maintenance Information message 12-012: [https://tulsa.tacom.army.mil/safety/mam/tacom\\_wn/MI12-012.html](https://tulsa.tacom.army.mil/safety/mam/tacom_wn/MI12-012.html)
