M777A2
Towed
Howitzer...

KEEP TOWING LUNETETTE TIGHT

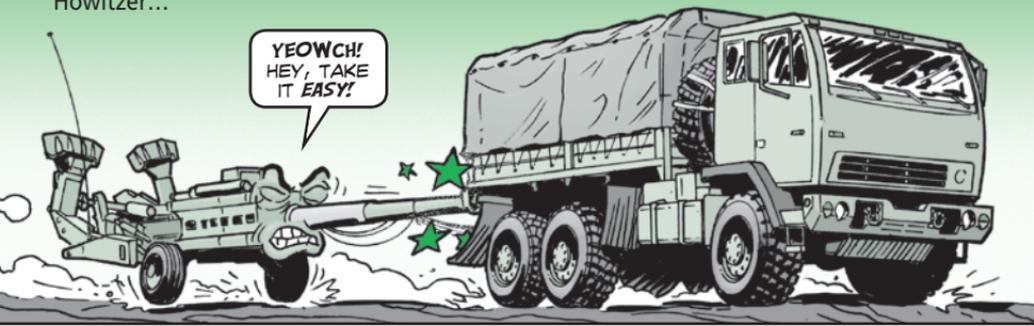
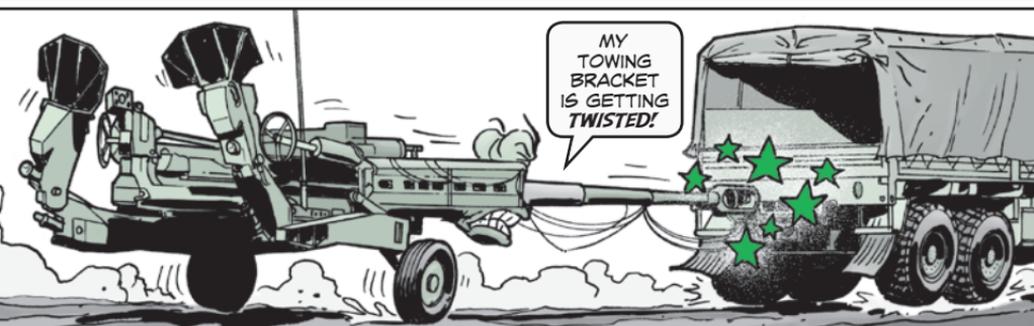
A LOOSE LUNETETTE ON YOUR M777A2 HOWITZER'S MUZZLE BRAKE CAN CAUSE NO END OF PROBLEMS!

If the lunette isn't tightened down properly, it allows a twisting motion during towing. It doesn't take too much twisting to damage the muzzle brake's tow bracket. The fix requires a depot-level welding and re-machining of the bracket.

You can prevent that expensive damage by making sure both the washer, NSN 5365-01-528-9349, and long nut, NSN 5310-01-528-9347, are in place. Then keep the long nut torqued to 350 lb-ft.
