MRAP M-ATV...

Battery Cable Pinch

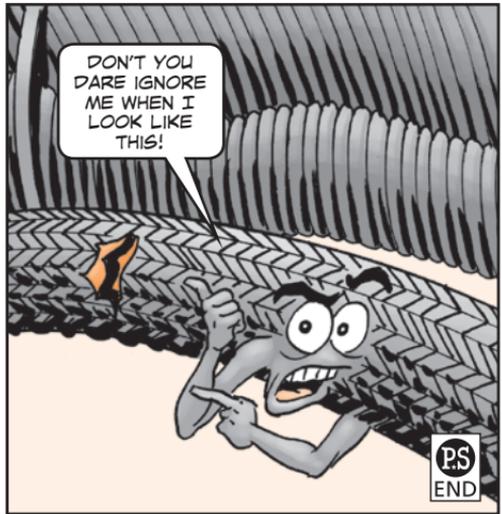
In another case, a battery cable behind the hull shorted out against the Roxtec armor cover. This fire occurred behind the hull, directly above the front of the fuel tank!

Plain and simple—a damaged or chafed battery power cable renders the M-ATV NMC.

The headshed is working on a solution to stop these fires with added wire insulation or re-routing. But until they do, tell your mechanic about any chafing or damaged cables **PRONTO!**
