Spindle Is Key to Tire Leak Mystery!

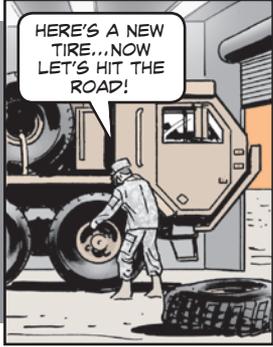
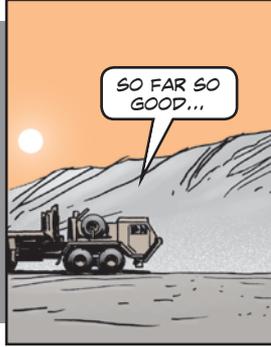
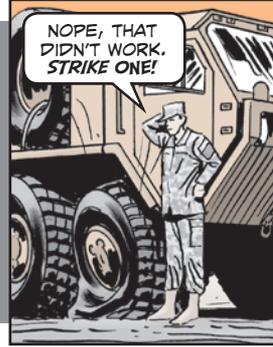
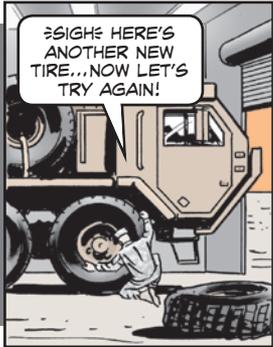
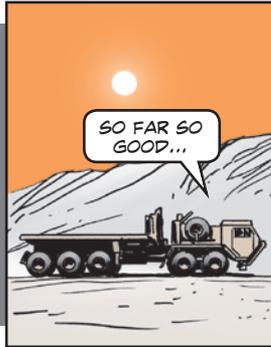
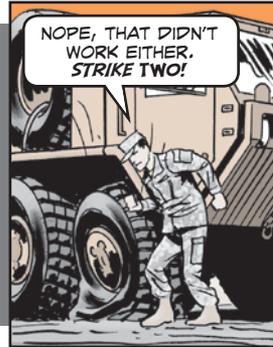
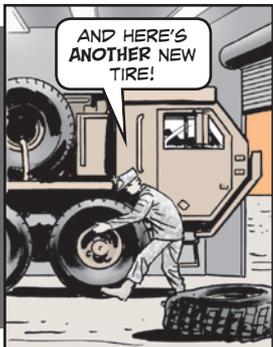
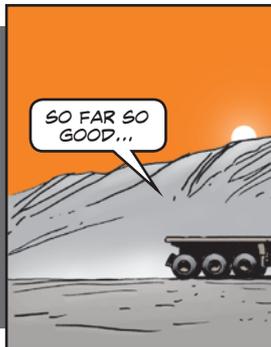
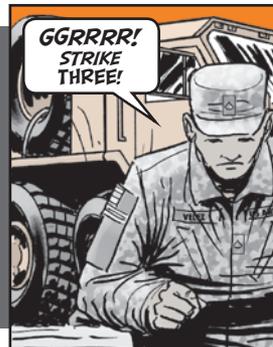
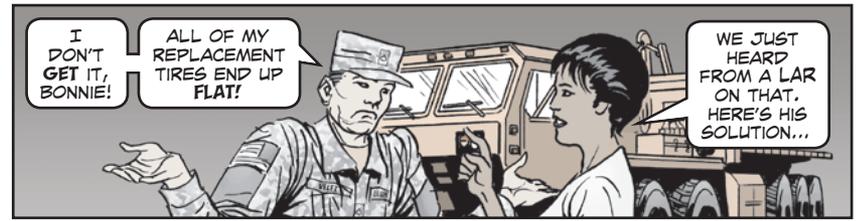
Finally, the truck's front axle was taken apart down to the spindle. We found that one of the three holes drilled on the back side of the spindle for the central tire inflation system (CTIS) had a check ball that was depressed into its machined hole. The spindle was compared to a known good one, and its check balls were *NOT* depressed into the machined holes.

We replaced the spindle on the truck and the problem was corrected.

This has happened with a few other trucks Army-wide, so your readers can save a lot of trouble by checking the spindle if they ever get a slow leak that won't go away with normal troubleshooting.
