# TARGETING TIPS FOR ACCURACY

# THE RIGHT MWO FOR YOUR BRADLEY

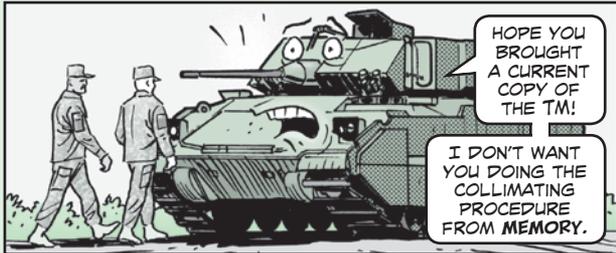
*Use hand station for last M242 zeroing step.* To zero the M242, you are supposed to hand crank the turret until the M242 is lined up with the target. Shoot one round. If the reticle jumps off target, use the crank to put the reticle back on target. Then push AIM POINT and use the hand station to align the reticle with the round's point of impact.

The problem is that crews use the crank instead of the hand station to do that last step. The M242 isn't really zeroed as a result. All they need to remember is to use the hand station for the final step to get it right.

Crews can find the correct procedure in Para B-77 in FM 3-20-1, *HBC Gunnery Manual*, which explains how to zero the Improved Bradley Acquisition System (IBAS) to the M242.
