# CORROSION COULD *DEADLINE* YOUR VEHICLE

If your unit has M967A1, M967A2, M967P1, M967A1P1, M967A2P1, M969A1, M969A2, M969A3, M969P1, M969A1P1, M969A2P1, M969A3P1, and M970A1 fuel tankers, inspect each vehicle. TACOM SOUM 13-008 gives you details on what to do. It's available at:

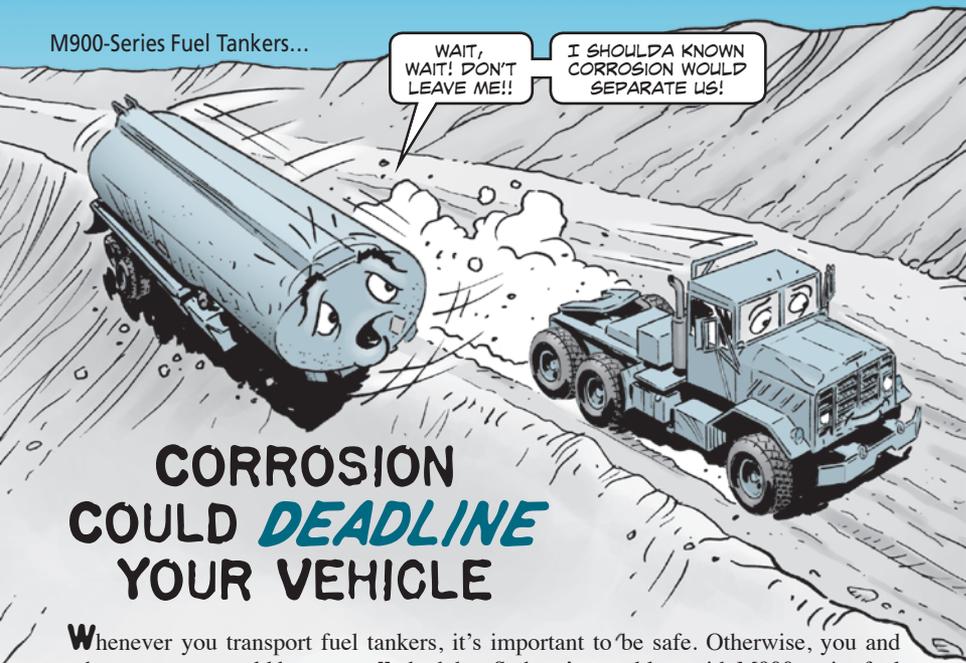
A recent inspection found too much corrosion around the upper coupler plate and frame structure. Corrosion build-up weakens the frame structure and can cause the fuel tanker to separate from the prime mover. But you can prevent this from happening.

Unbolt and lower the kingpin coupler weldment from the tanker following the instructions in the TM that supports your model. That allows you to inspect the kingpin coupler weldment and the tanker's main frame structure.

Remove any rust or paint flakes on the kingpin coupler weldment. That'll help you determine the actual amount of deterioration.

When overall thickness is less than .319 inches, the upper coupler isn't repairable and the tanker is deadlined. You'll have to remove and replace the king coupler weldment to bring your tanker back to a fully mission capable (FMC) status.

First, remove all corrosion and old paint. Next, treat and repaint the area following the spot painting guidance in TB 43-0242, *WD CARC Spot Painting*. Then insert drainage holes in the kingpin coupler weldment.
