M224,
M224A1
Mortar...

GET THE TORQUE RIGHT

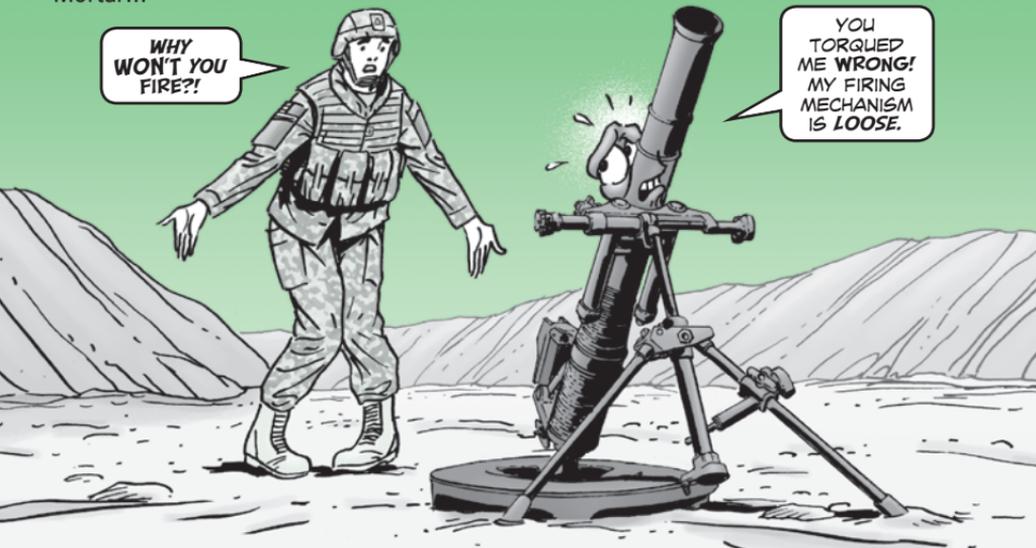
If the hardware for the handle and firing mechanism on the M224 and M224A1 mortars isn't torqued correctly, the mortars may not fire.

*M224: Tighten the self-locking screw and nuts to 10 + 2 lb-ft (13.6 + 2.7 N·m).

*M224A1: Torque the two new self-locking nuts to 10 + 2 lb-ft (13.6 + 2.7 N·m). Torque the shoulder screw into the loop clamp to 12.5 + 2 lb-ft (17.0 + 2.7 N·m).
