NO IMAGE? CHECK RETAINING RING

MK 19 Machine Gun...

Sear, Feed Slide SMR Codes Wrong

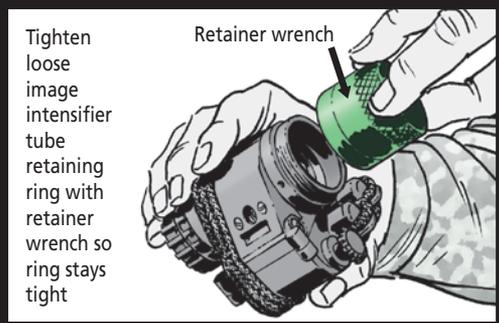
When the retaining ring isn't installed right, it can loosen. That allows the light pipe and image intensifier to shift in the housing. The light pipe can no longer project the IR indicator light or low battery indicator in the field of view. That makes the AN/PVS-14 NMC.

And if the retaining ring loosens completely, the image intensifier won't work at all.

The following faults are indicators of a loose retaining ring:

- Low battery indicator doesn't light
- Image intensifier doesn't glow green
- IR illuminator fails
- IR indicator light doesn't work
- A noticeable rattle when the NVD is handled

If the problem is a loose retaining ring, remember you must use the retainer wrench, NSN 5120-01-170-5088, to tighten the ring or it won't stay tight.

The troubleshooting table in TM 11-5855-306-23&P will be revised to add a check for a loose image intensifier tube retaining ring. There will also be an enhanced maintenance training package coming out for the AN/PVS-14.
