# CURE SLUGGISH FIRING

Some units are reporting that their new M2A1 machine guns are firing sluggishly. If your M2A1 just doesn't have any get-up-and-go, energize it like this:

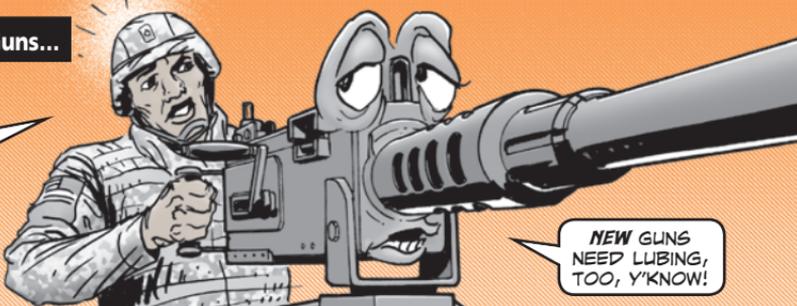
WHAT'S WRONG WITH YOU? YOU'RE BRAND NEW AND YOU HARDLY FIRE!

NEW GUNS NEED LUBING, TOO, Y'KNOW!

Make sure the preservative packing oil is completely removed and the weapon is lubed like it says in TM 9-1005-347-10. If the packing oil is left on or the weapon isn't lubed, the weapon will fire sluggishly. That's why it's so important to do the -23&P's Service Upon Receipt on new M2A1s before they go to the field.

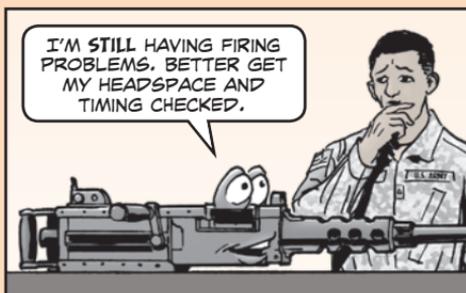
But if you've cleaned and lubed your M2A1 completely and it's still firing poorly, the problem may be that the buffer discs on the back plate are saturated. To check for this, repairmen should remove the disks following the procedure in WP 0017 of the -23&P. Replace wet disks with NSN 1005-00-515-2835.

Backplate discs saturated?  
Replace 'em!

When reassembling the back plate, make sure there's no in-and-out movement of the recoil mechanism buffer. You may need to add an extra disk if it's loose.
