BENT BRACKET CAN FREEZE UP Ruh-Ruh-Ruh-Ruh-Ruh-Ruh-Ruh-Ruh-Ruh RELAY!

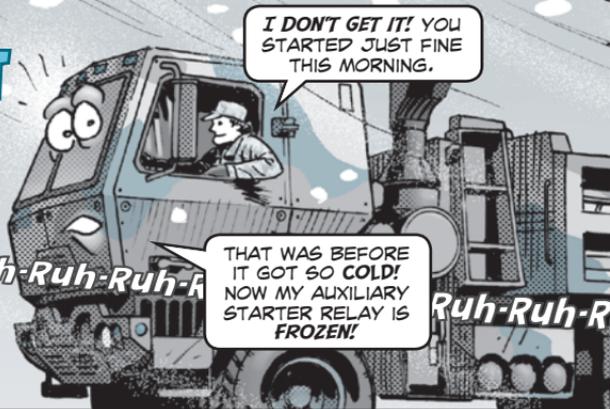
We've discovered that the auxiliary starter relay mounting brackets on some of our new M1157A1P2 10-ton dump trucks were bent at the factory.

During installation, the top washer is catching against the housing bracket. As the nut is tightened, the bracket bends upward. Unfortunately, that lets moisture inside the solid relay, NSN 2920-01-361-5802. In cold weather, the water freezes and keeps the truck from starting until the relay thaws.

Right now, your best option is to replace the solid relay and then submit a PQDR. Submit the PQDR at: <https://www.pdrep.csd.disa.mil/>
