# The Shot Heard 'Round the Turret

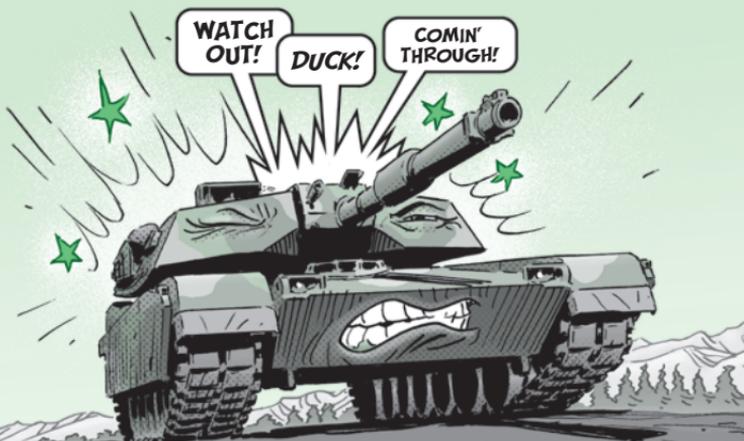
Our brigade has found a lot of bolts, NSN 5305-01-336-8241, missing from the breech crank assembly on M1-series tanks. Either the crews have been removing the bolts, which they're not supposed to do, or the bolts are coming loose and falling out on their own.

Either way, the bolt; spring, NSN 5360-12-189-0284; and nut, NSN 5310-01-336-3521, on the breech crank assembly end up missing. When that happens, the closing piston comes apart and shoots across the turret, especially during firing. That's a good way to hurt someone.

Crews should check the breech crank assembly and report any bolts that are loose or missing to their mechanic. He'll apply sealing compound, NSN 8030-01-025-1692, to the bolt's threads like it says in WP 0813 of TM 9-2350-388-23-2-4 (Jan 09, w/Ch 1, Oct 11) and WP 1359 of TM 9-2350-264-23-2-6 (Jul 11, w/Ch 2, May 13). That'll keep those pins tight and our tank crews safe.

Mechanics, make sure you use the safety clip, NSN 5340-01-205-9963, to keep the piston in place while adding sealing compound to the breech crank assembly bolt. See WP 0774 in TM 9-2350-388-23-2-4 and WP 1342 in TM 9-2350-264-23-2-6 for more information.
