M1-Series Tanks...

BEAT BACK FLAREBACKS

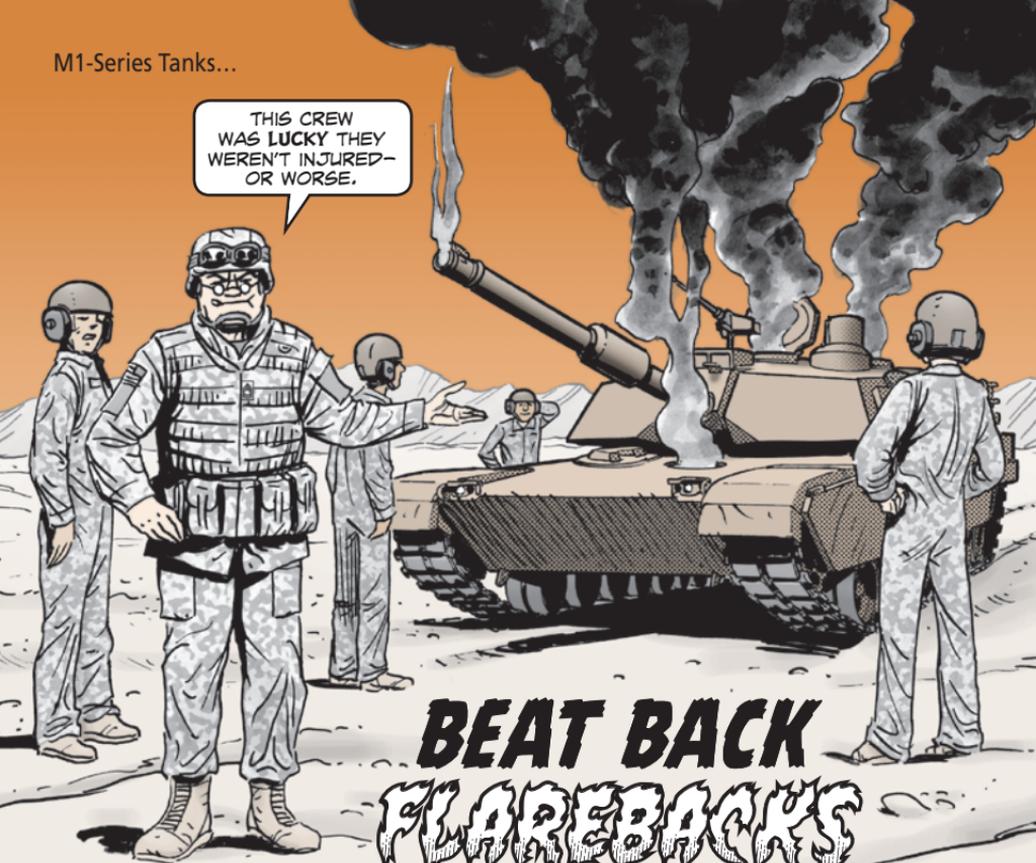
THIS CREW WAS **LUCKY** THEY WEREN'T INJURED—OR WORSE.

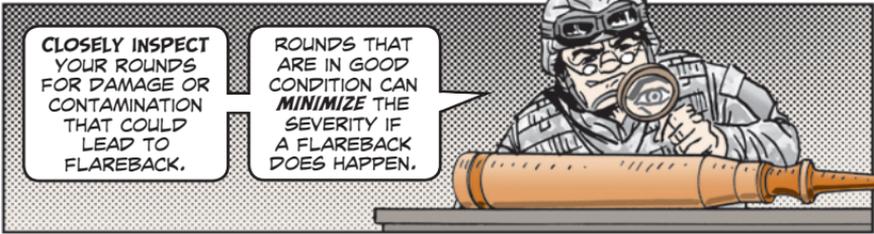
Inspecting the rounds themselves is also a critical step in flareback prevention. Rounds that are contaminated with water, oil or other substances might not burn completely. The residue left behind could ignite any gases not expelled by the bore evacuator.

Inspect rounds for contamination before firing
