DON'T LET HATCH SPRING A SURPRISE!

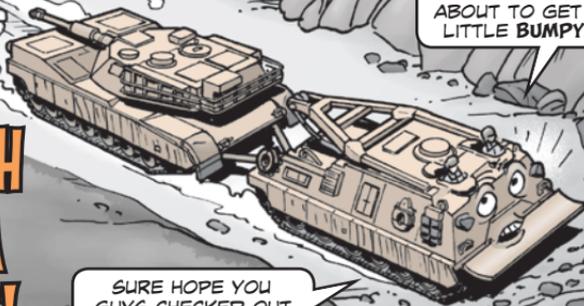
A driver was hurt recently by a hatch that closed without warning. The accident was caused by a worn-out spring in the hatch lever's safety latch.

Inspect your M88's hatch levers right away. Follow the PMCS checks in TM 9-2350-256-10 (Oct 14) for the A1 and TM 9-2350-292-10 (Oct 14) for the A2. Make sure the helical torsion spring, NSN 5360-00-999-5125, is properly tensioned and that the latch spring is mounted in the small hole that anchors it to the housing.

If the hatch lever doesn't operate smoothly or have full range of motion, replace the helical torsion spring. It's listed as Item 16 in Fig 221 of TM 9-2350-256-24P-1 (May 92, w/Ch 2, Aug 98) for the A1 and Item 29 in Fig 241 of TM 9-2350-292-24P in IETM EM 0266 (Jun 07) for the A2.
