SHOW RESTRAINT WHEN CLOSING THE DOOR

Here at Ft Leonard Wood, MO, we're seeing a lot of driver's side restraint systems damaged on M1157A1P2 LTAS FMTVs.

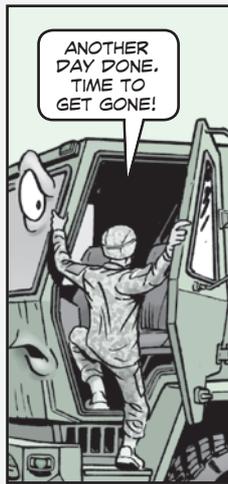
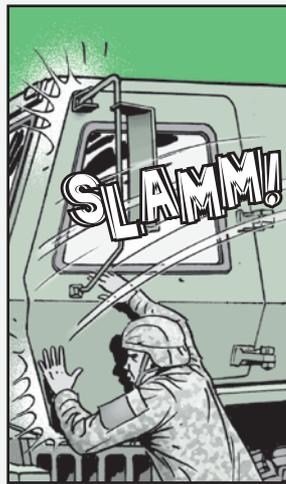
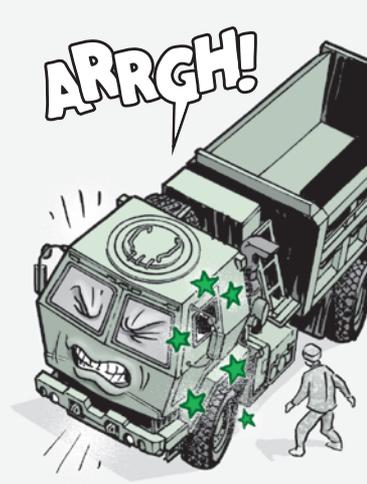
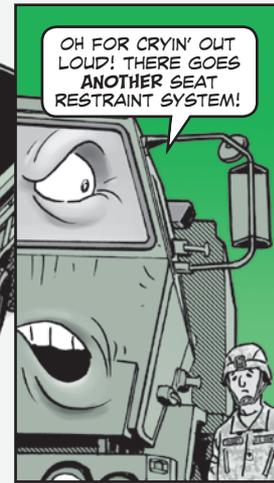
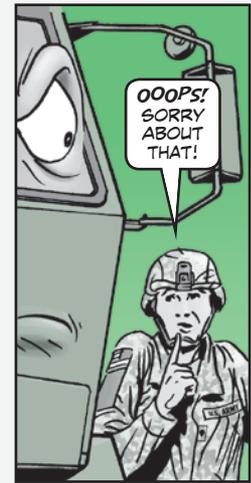
If the driver doesn't make sure the four-point seat belt is inside the cab before shutting the door, the belt's restraint latch gets slammed between the door and door jam. This not only damages the door and jam, but the heavy doors often ruin the safety pull tab (latch guard) on the restraint latch.

According to the before operations PMCS checks in TM 9-2320-333-10, any part of the restraint system that is missing or damaged makes the vehicle NMC.

A new restraint system, NSN 2540-01-528-1903, costs about \$260. But we've found a better solution. If the safety pull tab is the only part damaged, units can get a replacement from Mastercraft, Inc., for just \$12.95. Just order on a DD Form 1348-6 using PN 500976-443 and CAGE 3UKX4. That PN also includes the screw and nut to hold the pull tab in place.

Of course, the best fix would be for operators to make sure the vehicle's seat restraint is clear of the door before closing it.

As a quick field-fix, you can use some 550-cord to serve as a temporary pull tab. Make sure you tie a knot in the middle of the cord so it doesn't wrap around the latch. Then get the tab replaced when you get back to the motor pool.
