PS**THE
PREVENTIVE
MAINTENANCE
MONTHLY**

ISSUE 670 SEPTEMBER 2008

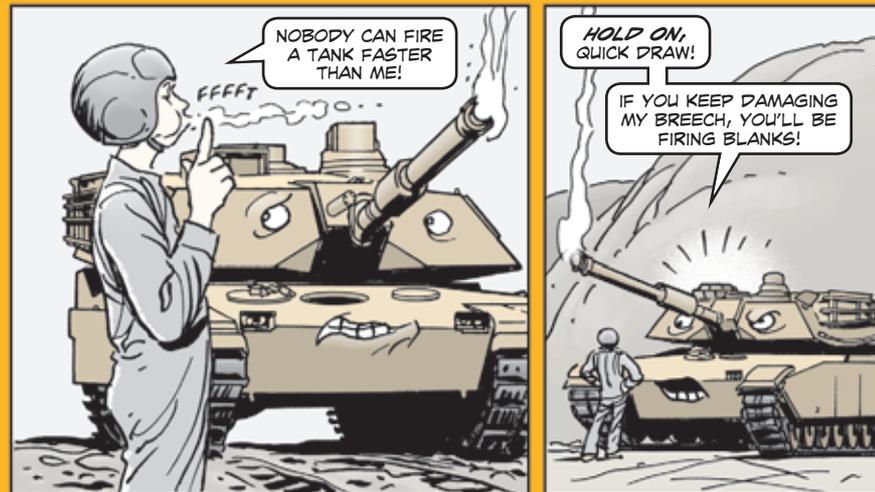
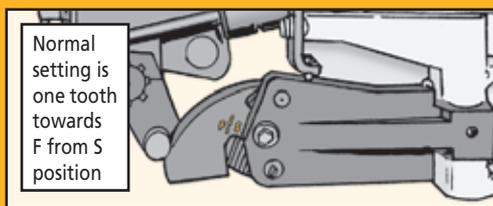
Cam Setting Makes a Difference

But setting the cam to the F (fast) setting doesn't speed up the recoil. It just forces the stub base to be ejected more aggressively. That causes extra stress and wear on the breech components and can lead to premature failure.

So, check the cam in your tank now. The normal operating position is one tooth towards F from the S (slow) position. Then, adjust the cam only if it becomes necessary—when the stub bases eject too slowly because of cold weather.

You'll find the instructions for adjusting the cam starting on Page 3-266 of TM 9-2350-264-10-2, Page 3-160 of TM 9-2350-288-10-2, and Page 3-188 of TM 9-2350-388-10-2.

And don't forget to return the cam to its normal setting when that cold snap ends.

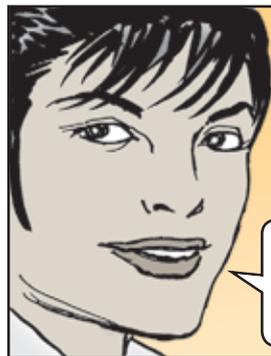
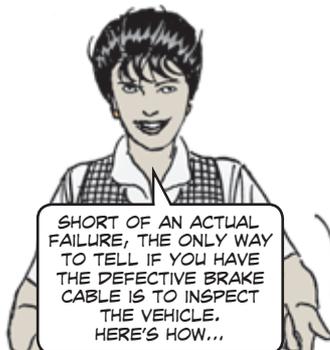
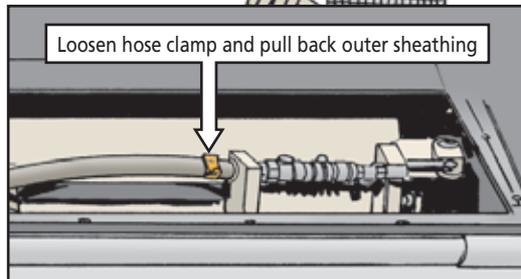
Check the Brake for Goodness Sake!

THE INNER CORE CONDUIT IN THE BAD CABLES DOESN'T HOLD UP TO HIGH TEMPERATURES.

ENGINE HEAT CAN CAUSE THE CONDUIT TO MELT.

IF THAT HAPPENS, THE BRAKES MAY NOT RELEASE AFTER THEY'RE ENGAGED AND THE TRANSMISSION COULD BE DAMAGED.

SHORT OF AN ACTUAL FAILURE, THE ONLY WAY TO TELL IF YOU HAVE THE DEFECTIVE BRAKE CABLE IS TO INSPECT THE VEHICLE. HERE'S HOW...

Access the service brake cable through the exhaust duct door panel assembly. Loosen the hose clamp holding the outer sheathing on the cable in place.

If the service brake cable is green, you're good to go. However, if the cable is black, you're not finished.

The bad cables will have 19207-12273440 stamped on the cable. Note that the "2" in the 19207 may appear to look like a Z. These cables should be replaced and an SF 368, *Product Quality Deficiency Report*, submitted for credit and disposition instructions.

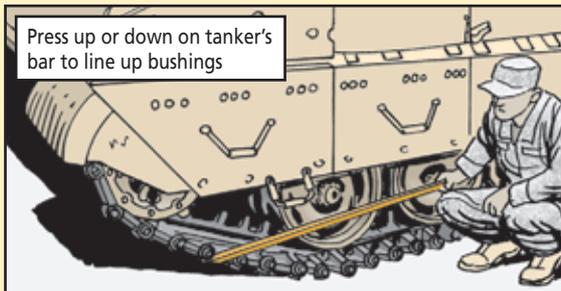
A lot of guys try to bang home the pin with a sledgehammer. That may work in the short run, but it causes damage to the pin and bushings that will eventually result in track failure.

Press up or down on tanker's bar to line up bushings

We've found that you can use a tanker's bar to help with the connection. Just wedge the end of the bar between the two shoes and pull up and down to manipulate the bushings until they line up. Then the pin slides in easily.

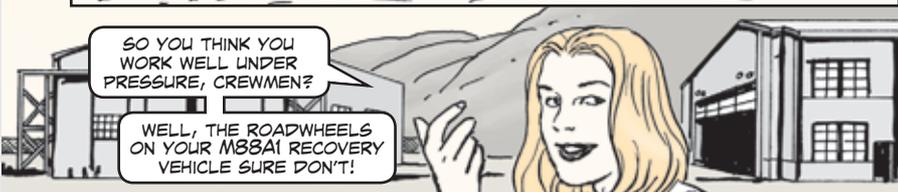
A roadwheel relief valve that's clogged with dirt and sand won't relieve pressure when you pump in new grease. The pressure grows until something gives—usually the hub seal.

When the seal goes, so does the lube. The result is burned-out bearings.

Plunger on relief valve should move easily

If it slides out smoothly and pops back in when you release it, the valve's OK. If it doesn't, replace it with relief valve, NSN 4820-01-070-7670.

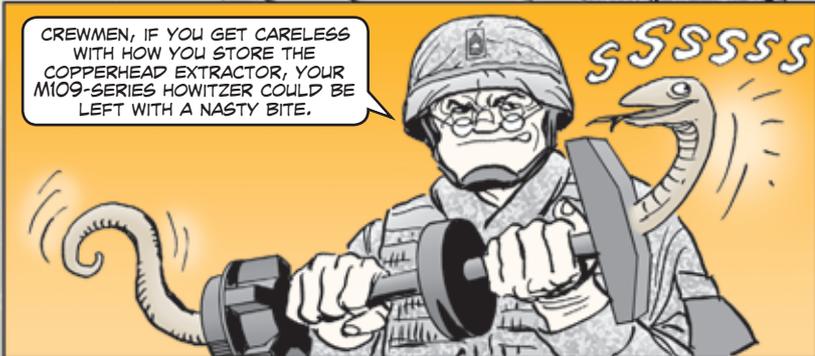
If you store it backwards, or with the brace in the vertical position, the brace bangs into the wiring harness that powers the slip ring contact arms. Banging wears away the harness cover and leads to arcing and electrical failure.

Slide the brace forward on the extractor shaft until it touches the end of the ratchet handle. Turn the drive nut on the shaft end counter-clockwise until the brace is held firmly against the ratchet handle.

Then, turn the extractor so that the brace is horizontal and facing away from the rear door when it's stored in the cab rack. That way, you avoid harness damage altogether.

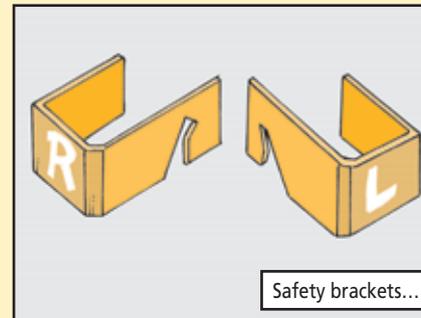
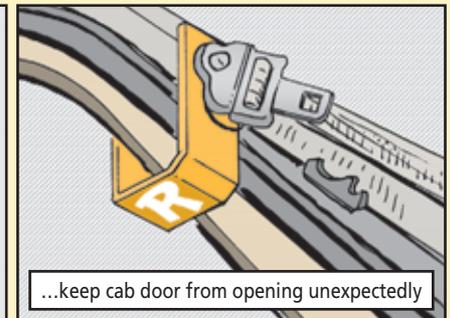
Recently we pulled maintenance on some FMTVs, and the cab doors opened when the cab was raised. Imagine our surprise! This was a hazard to anyone standing near the doors and could have damaged equipment.

Editor's note: Great idea! Normally, FMTV cab doors don't pop open when the cab is raised. But it **can** happen if the door isn't fully latched or properly adjusted, or if the cab is bent out of alignment. And on older models, the door can open when the linkage becomes weak or loose.

Safety brackets...

...keep cab door from opening unexpectedly

TACOM LCMC approved some linkage changes to solve this problem, but not every truck was updated with the improved hardware. So if the cab door on your FMTV opens when the cab is raised, inspect the door linkage and door for proper adjustment. Check the cab structure for damage, too. And to be on the safe side, make this safety bracket.

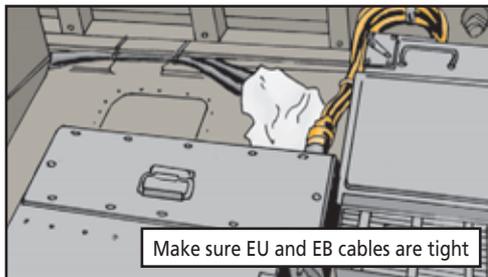
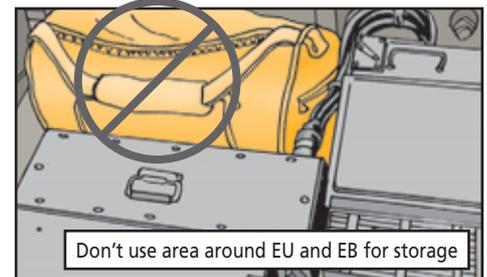
No storage. The area around the EU and EB may look like convenient places for storage, but they're definitely not. If you stick stuff like chock blocks or duffel bags there, the launcher will crush them when it's stowed.

Don't use area around EU and EB for storage

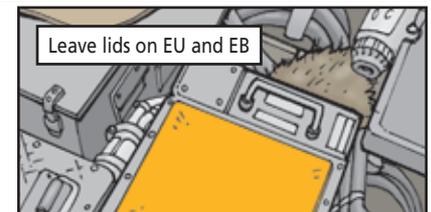
Leave the lids on the EU and EB. Only support should take off the lids. If you remove them, the gaskets that keep the lids watertight are ruined.

Leave lids on EU and EB

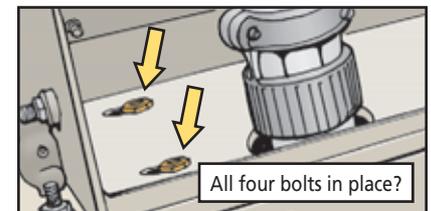
Make sure all four bolts that hold the EB to the battery box are in place and are tightly screwed in with the correct washers and gaskets. Often the two bottom bolts are forgotten and that can let water into the EB.

All four bolts in place?

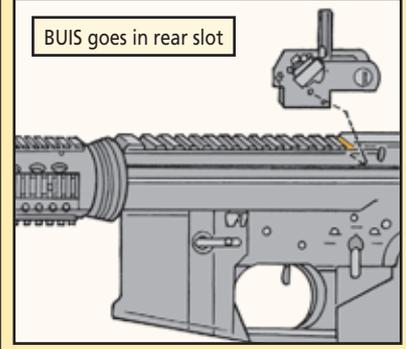
For M4/M4A1, use 300-m mark

For M16A4, set sight between 300-m and 400-m marks

Dear Chief D.C.,
 Good question. First of all, for accurate zeroing, the BUIS must be in the last slot to the rear.
 For the M4/M4A1, the line on the left-side cam must align with the 300-m mark. For the M16A4, the line should be between the 300-m and 400-m marks.

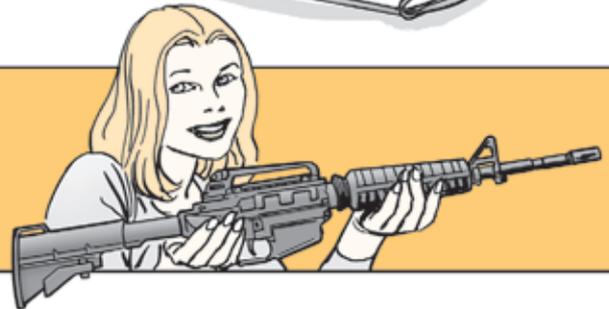
THE M16 RIFLE AND THE M4/M4A1 CARBINE CAN NOW USE THE SAME EXTRACTOR SPRING ASSEMBLY.

New extractor spring is gold with a black insert

The old extractor spring assembly, NSN 5360-01-424-5899, is still in stock and may be ordered for use only on the M16. The old breach bolt assembly, NSN 1005-01-422-3770, is also still in stock and may be ordered only for the M16.
 Once stock of the two assemblies are exhausted, order only the newer extractor spring assembly, NSN 5360-01-505-2886. It's gold colored—the old one is dark colored. Order the new breach bolt assembly with NSN 1005-01-505-1035.

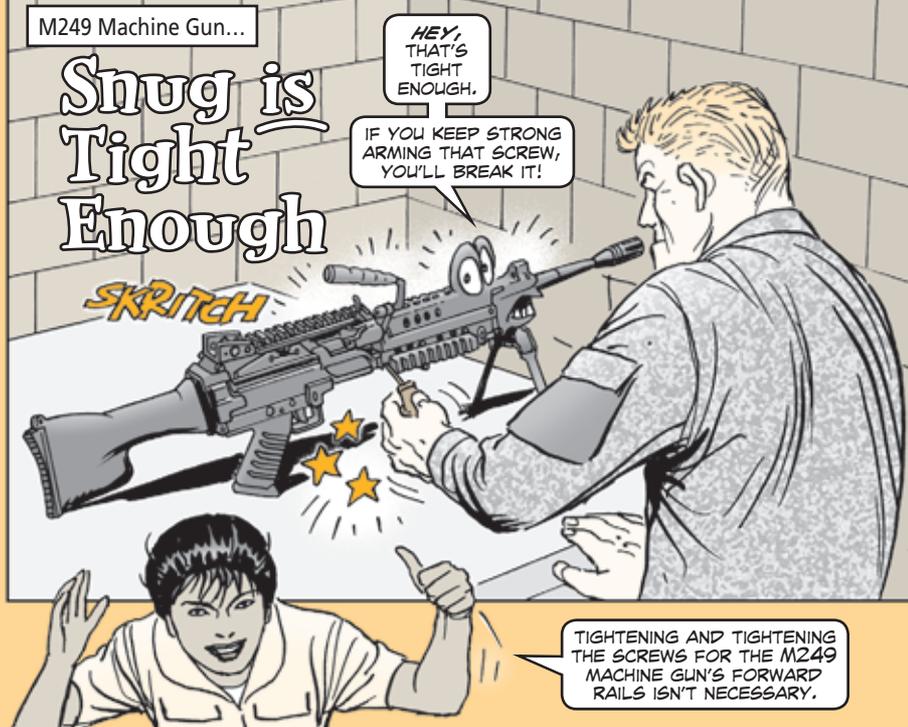
Snug is Tight Enough

The screws are self-locking, so once they're tightened snug the forward rails should be tight. If you continue to tighten the screws, you strip or break them.

Out-of-round holes are usually caused by your repairman mistakenly thinking the forward rails don't fit. So he enlarges the holes. That makes it impossible to keep the forward rails tight.

If the rails aren't tight, armorers, remove the screws and the forward rails. Check the receiver holes where the forward rails' studs go. If the holes are out-of-round, the M249 needs to be turned in because you will never be able to securely mount the forward rails to the receiver.

If the studs don't fit into the holes easily, your repairman should use a rubber mallet to tap the forward rails into place. That should do the trick. Enlarging the holes accomplishes nothing but ruining the receiver.

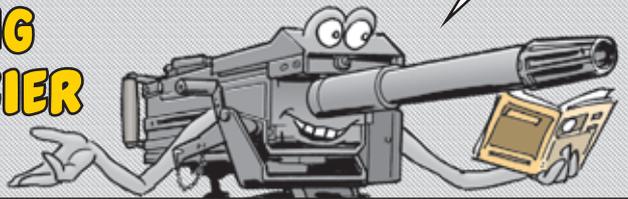
The Army is fielding a new pivoting coupling that lets MK 19 gunners link individual grenade rounds or partial or full ammo belts together without hand tools. The new couplings are gold, not black like the old ones. Before using them, heed these warnings:

- Do not couple target practice and high explosive rounds together. You don't want any confusion over what you're firing.
- Do not re-couple rounds if the link is off the rotating band. The link or rotating band may be deformed, which would cause the MK 19 to stop firing.
- Do not uncouple belted ammo. That can damage the coupling and keyhole.
- Improperly linked ammo can cause the MK 19 to stop firing.

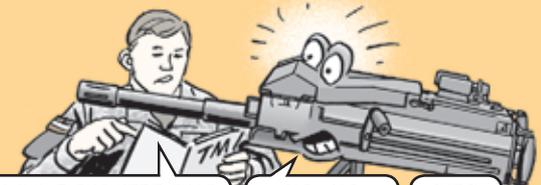
WHO DISASSEMBLES COVER ASSEMBLY?

Dear Half-Mast,
 TM 9-1010-230-23&P is confusing on what level of maintenance should disassemble the MK 19's top cover assembly. WP 004700-1 says the armorer should inspect, remove and repair the top cover assembly. But the note on the next page says not to disassemble the top cover unless you need to replace a part. In the repair parts list on WP 010500-3/4, it states that all the top cover repair parts are at the direct support level. So what's right?
 D.H.

Dear Mr. D.H.,
 The armorer is **not** authorized to disassemble the top cover assembly. The only part of the assembly the armorer should inspect is the latch mechanism. All repairs and disassembly of the top cover should be done by support. The TM will be changed to make this clear. Thanks for pointing this out.
 Half-Mast

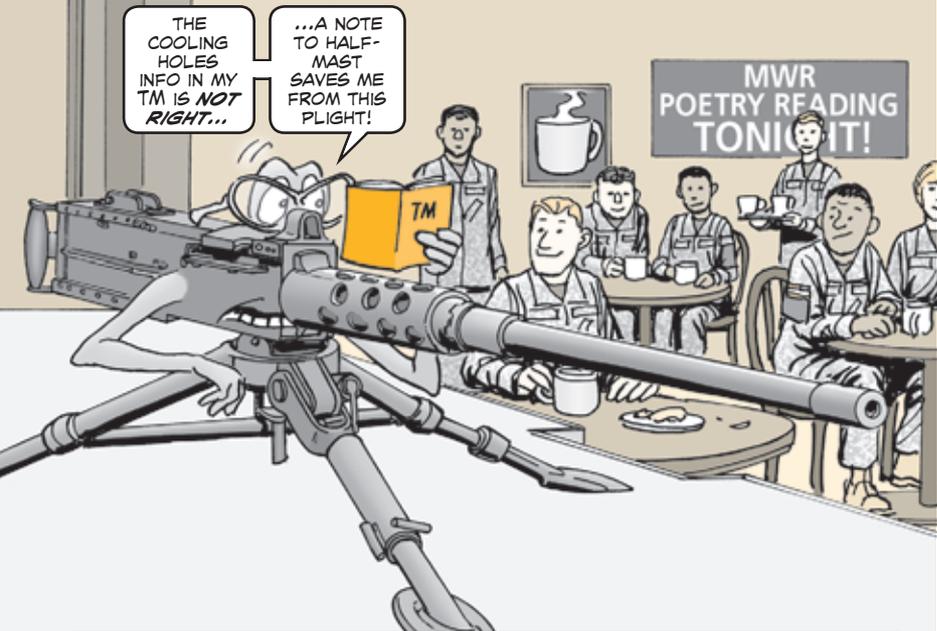
TB 9-1000-247-34 says that cracks up to 1/4 inch long are permitted at cooling holes, but Step 3 on WP 0020 00 in TM 9-1005-213-23&P says "Cracks up to 0.025 inch (0.635 mm) maximum in length are permitted at holes". That's quite a difference. What's right?

Step 3 in the TM should read 0.250 inch (6.350 mm), so make a note in your TMs until this is corrected. The rest of Step 3 is correct: "No more than four cracks allowed per support. No more than two cracks allowed in succession in any direction. Original surface imperfections are permitted."

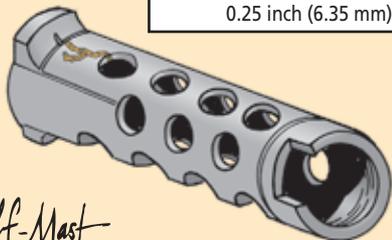
Cracks can't be longer than 0.25 inch (6.35 mm)

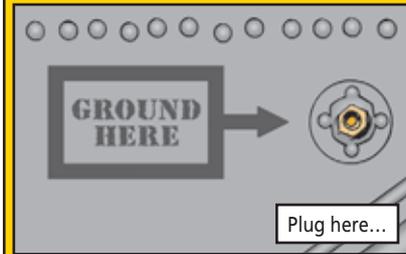
Plug here...

None of this has to happen. Rushing to disconnect a ground cable leads to broken parts. The only way to disconnect from a grounding point is to reverse how you hooked it up.

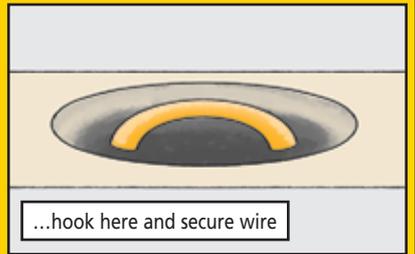
hook here and secure wire

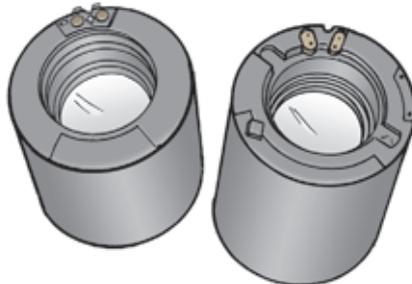
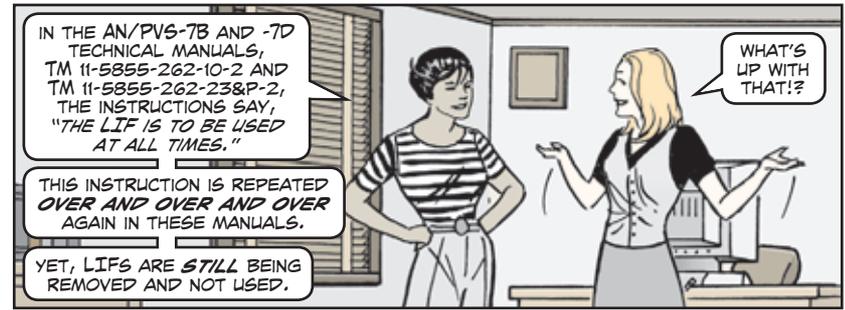
Your image tube cannot recover from bright light damage. The pixels in the tube will be damaged and leave a black, empty streak, an arc or spot.

Most of the light damage to image intensifier tubes could be prevented if the light interference filter (LIF), NSN 5855-01-379-1410, was being used.

One reason may be that some of you don't think you get as good an image with the LIF in place. And you're right. There is a slight reduction in system gain, but the emphasis is on the word **slight**. If you're getting too great a reduction, try cleaning the LIF using water and lens paper, NSN 6640-01-459-4239. If it's still a problem, get a new LIF!

If the LIF is dirty or scratched or otherwise damaged, it could be you're not using the sacrificial window, NSN 5855-01-246-8271. Use it! Its job is to give its life so the LIF and the tube can survive.

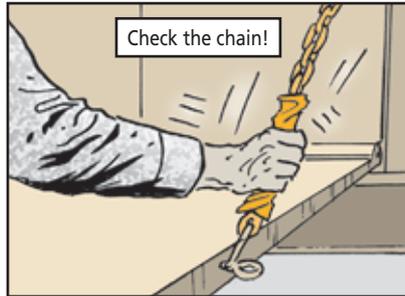
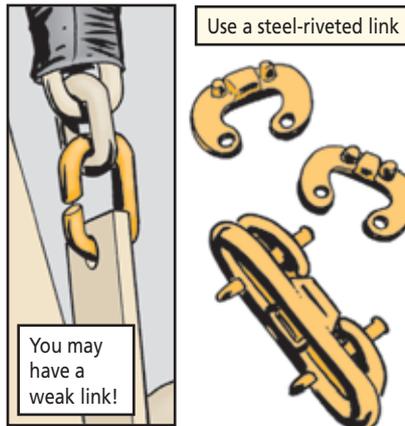
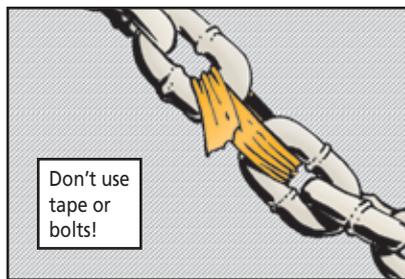
The last link of the chain—the one that joins the chain to the tailgate—might be aluminum. If it is, it just might fail! This could cause a soldier to take a tumble to the ground and be hurt.

Replace an aluminum link with a steel riveted link, NSN 4010-01-218-6340.

While you're checking this last link, check them all for rust and other signs of weakness. You might want to run that magnet over all the links just in case. Only standard welded links and the steel riveted hammer-lock type that you should use as a replacement link are authorized to be in the tailgate chain.

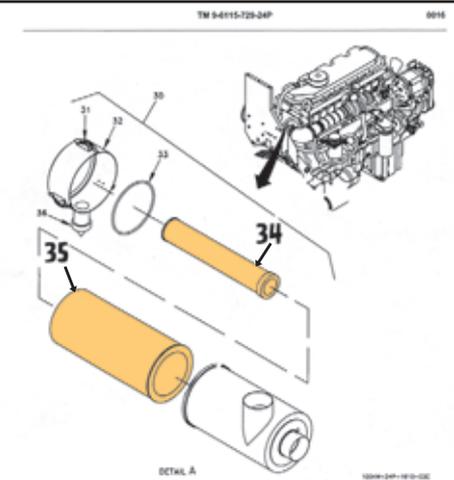
Dear Half-Mast,
I was about to order the inner intake air filter element, NSN 2940-01-158-1462, Item 34 in Fig 15 of WP-0016 in TM 9-6115-729-24P, for my 100-KW tactical quiet generator, when my chief told me that the NSN in the TM was wrong. Is my chief right? If so, what is the right NSN? And, does the outer element, Item 35, have an NSN?

Dear Sergeant D. G. Y.,
Never doubt a chief. They know! The right NSN for Item 34 is NSN 2940-01-559-9941. And the NSN for Item 35 is NSN 2940-01-560-8766. Correct the part number, too. The right part number for Item 34 is P533781.

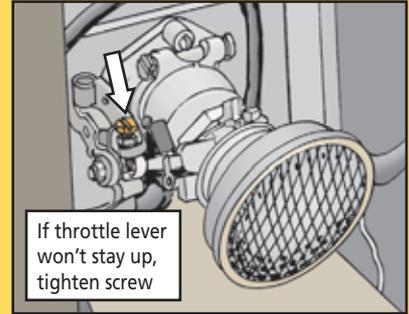
- The throttle lever constantly gets out of adjustment. Its screw loosens from vibration so much that when you push up the lever at shutdown, it drops right back down and the engine doesn't shut off. During PMCS, push the lever up and release it. If the lever won't stay up, tighten its screw, but not so tight that the lever is difficult to move.

If throttle lever won't stay up, tighten screw

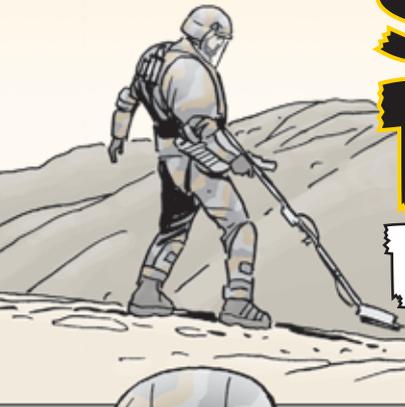
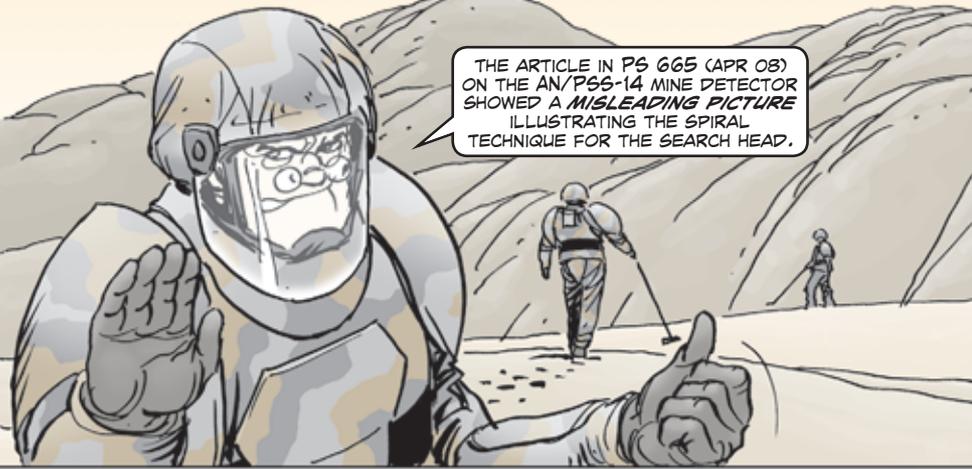
THE ARTICLE IN PS 665 (APR 08) ON THE AN/PSS-14 MINE DETECTOR SHOWED A MISLEADING PICTURE ILLUSTRATING THE SPIRAL TECHNIQUE FOR THE SEARCH HEAD.

THIS IS HOW IT **SHOULD** GO WHEN YOU'RE TRYING TO FIND THE CENTER OF THE MINE...

...IF THE METALLIC SIGNATURE IS AS LARGE OR LARGER THAN THE SEARCH HEAD, THEN YOU NEED TO USE THE SPIRAL TECHNIQUE. IT LOOKS LIKE THIS...

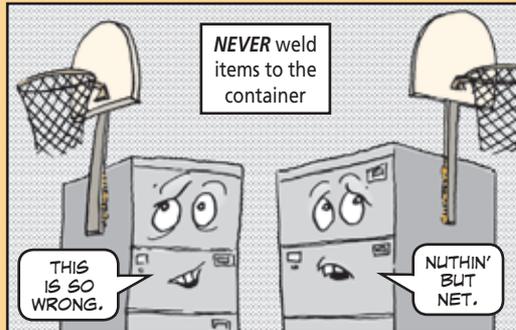
NEVER weld items to the container

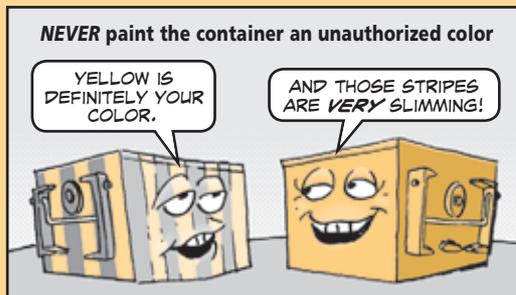
NEVER paint the container an unauthorized color

Use only the color authorized for that container

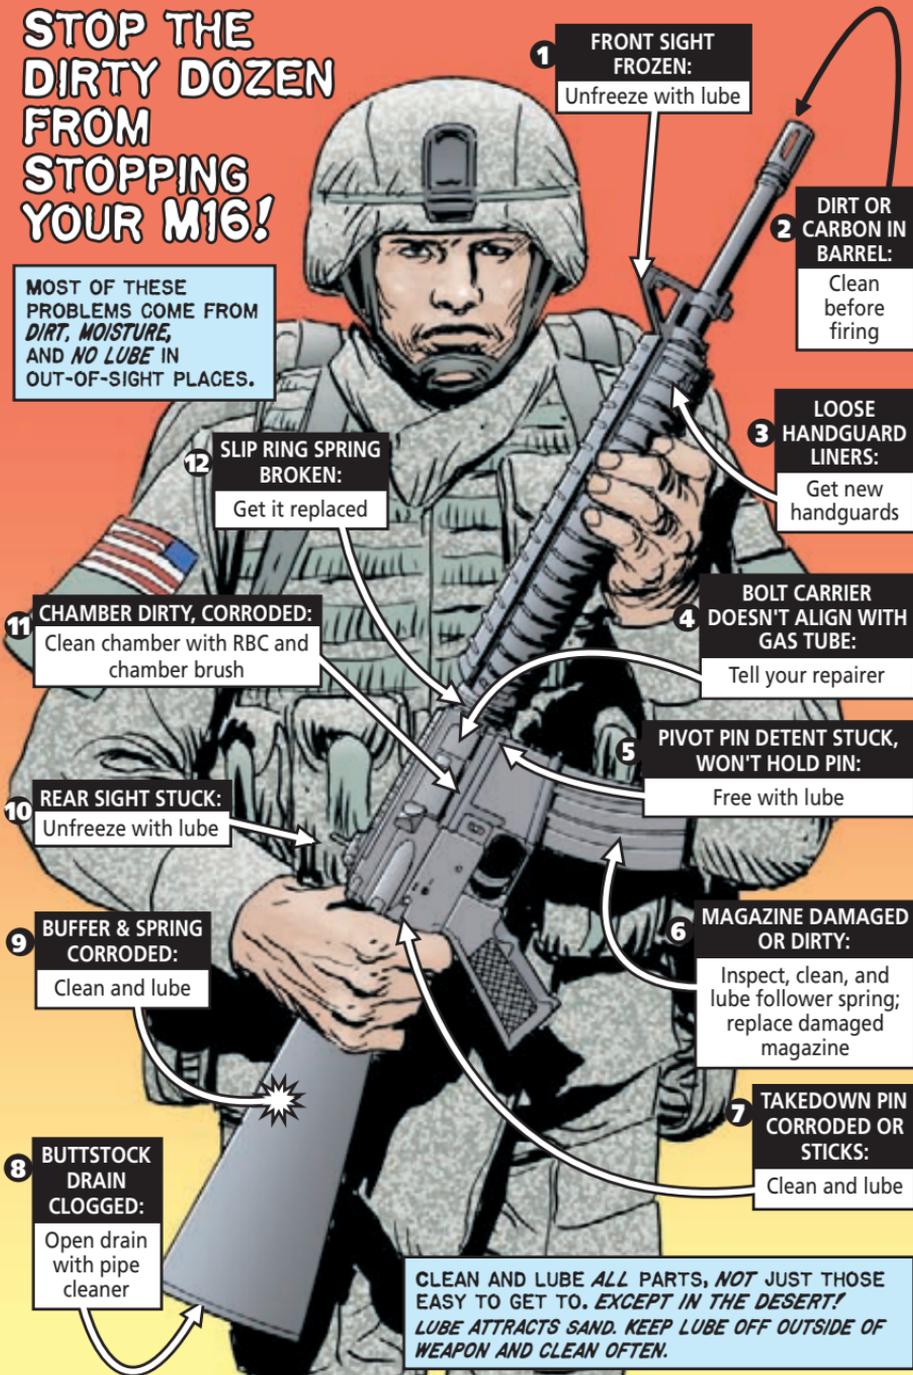
1 FRONT SIGHT FROZEN:
Unfreeze with lube

2 DIRT OR CARBON IN BARREL:
Clean before firing

3 LOOSE HANDGUARD LINERS:
Get new handguards

4 BOLT CARRIER DOESN'T ALIGN WITH GAS TUBE:
Tell your repairer

6 MAGAZINE DAMAGED OR DIRTY:
Inspect, clean, and lube follower spring; replace damaged magazine

7 TAKEDOWN PIN CORRODED OR STICKS:
Clean and lube

12 SLIP RING SPRING BROKEN:
Get it replaced

11 CHAMBER DIRTY, CORRODED:
Clean chamber with RBC and chamber brush

9 BUFFER & SPRING CORRODED:
Clean and lube
