TECHNICAL BULLETIN

**STANDARDS OF MAINTENANCE
FOR MILVAN CONTAINERS
OVERHAUL OR REPAIRED
GENERAL CARGO
NSN 8115-00-168-2275
WITH LOAD BRACING SYSTEM
NSN 8115-00-151-9953**

STANDARDS OF MAINTENANCE
MILVAN CONTAINERS
OVERHAULED OR REPAIRED
GENERAL CARGO
NSN 8115-00-168-2275
WITHLOAD BRACING SYSTEM
NSN 8115-00-151-9953

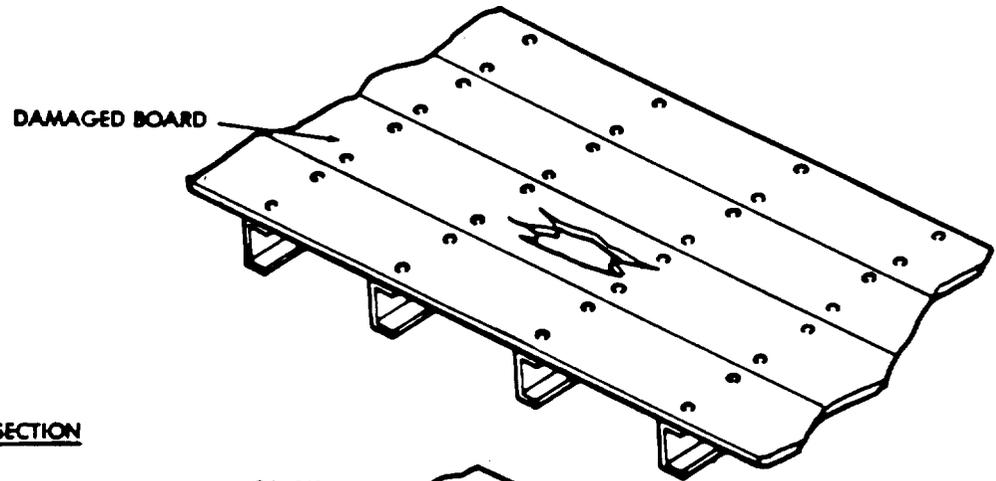
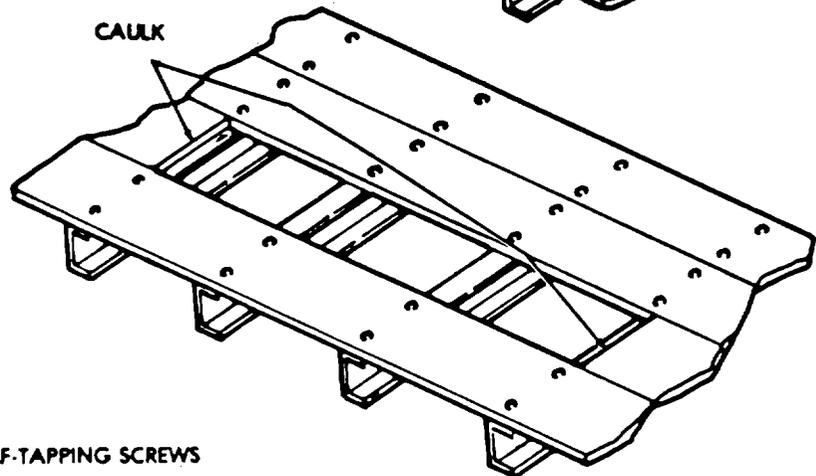
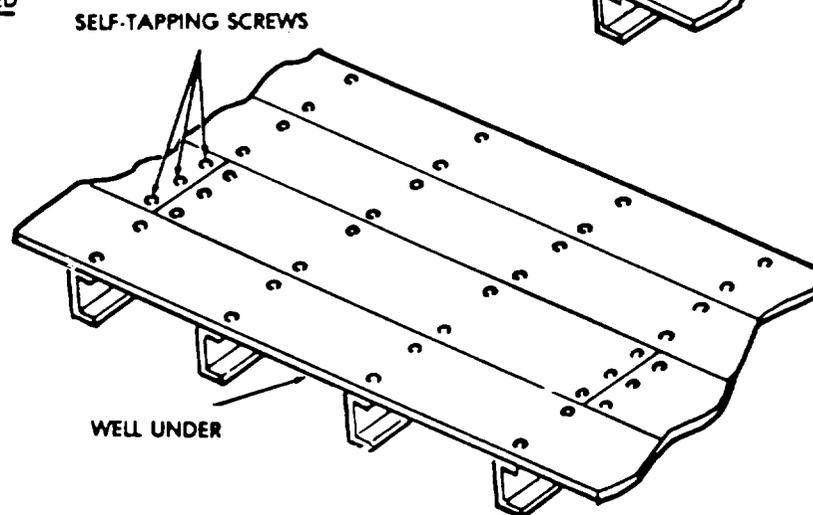
Figure No. 7. Wood Floor Repair.

DAMAGED FLOOR BOARDS

CUT DAMAGED SECTION

BOARD SPLICE INSTALLED

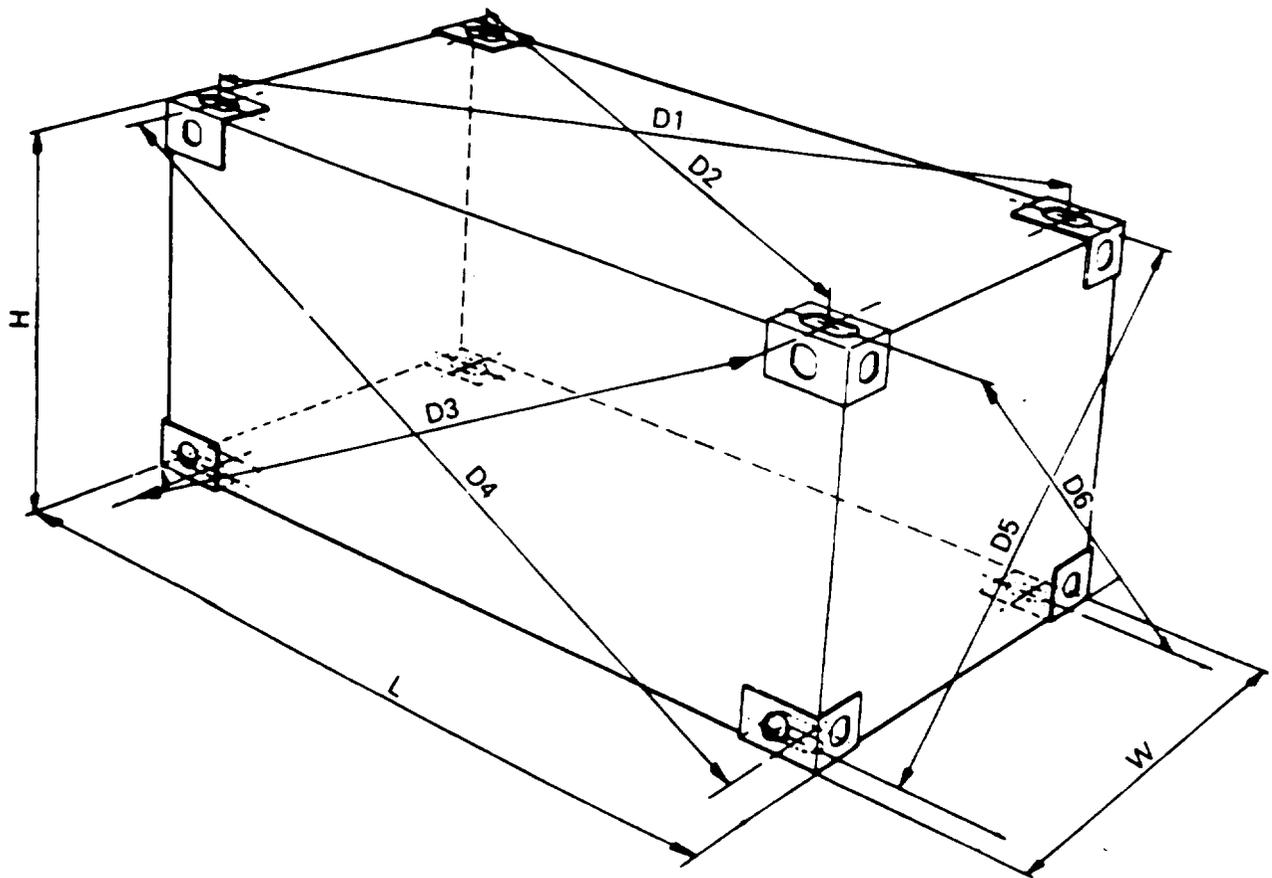
Overall Configuration - Racked container - a suspect container that has visual distortion to the extent that it would prevent proper alignment of handling equipment, mounting on chassis or insertion into ship cells. The over-all outside dimensions must be within the following tolerances:

- Over-all height 8' 0" (2438 MM) + - .19" (5MM)
- Over-all height 8' 6" (2591MM) + .19" (5 MM)
- Over-all width 8' 0" (2438MM) + - .19" (5MM)
- Over-all length 19' 10.5" (6058MM) + 0-.25" (6 MM) (20 foot long container)
- Over-all length 40' 0' (12192 MM) + 0-.38 (10MM) (40 foot long container)

- c. Door Header Drip. This area may be repaired by butt-welding an insert in the damaged area.
- d. After repair, the outside dimension (OD) (see figure 9) will not exceed 19 feet 10.5 inches, $\pm .25$ inches (6.062 m $\pm .076$ m), and the inside dimension (ID) will not be less than 19 feet 3 inches (5.80 m).
- e. After repair, the door opening dimension will be not less than 7 feet 5 inches wide (2.262 m) in width or 7 feet (2.135 m) in height.
- f. After repair, the entire container must be square at all corners.
