M1074/M1075 PLS...

# Level the Alternator Peaks

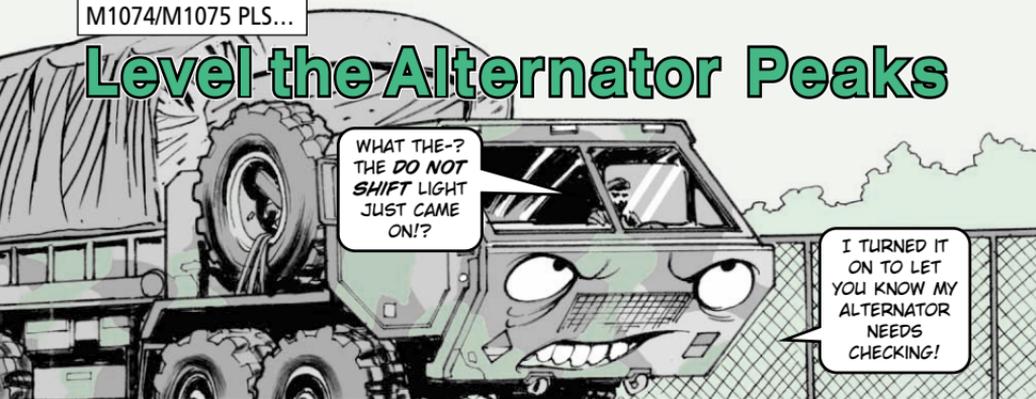
**S**ome PLS trucks are still having problems with the transmission not shifting or the DO NOT SHIFT lamp lighting up. Alternator voltage peaks are probably the cause.

Some PLS trucks, built between Aug 97 and Jun 99 with serial numbers 63479 through 66375, are experiencing voltage peaks on the 200-amp alternator. The peaks show up as DO NOT SHIFT lights on the dashboard, or even as a transmission that won't shift after the engine is started.
