ELSE...

CAN'T GET HELMET EARCUP ASSEMBLY

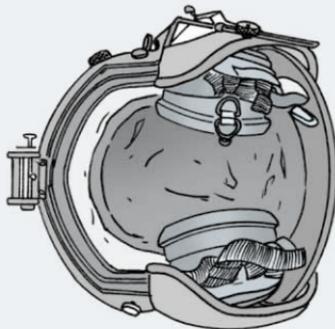
- Earcup assembly shell, NSN 5965-01-390-8873, Figure F-5, Item 1
- Ear cushion, NSN 5965-01-392-6179, Figure F-5, Item 2
- Receiver retainer, NSN 8415-01-330-6618, Figure F-5, Item 3
- Seal assembly, earpad, NSN 8415-01-074-1622, Figure F-5, Item 4

The problem is an incorrect SMR code listed for Item 12 in Figure F-2 of TM 1-8415-216-12&P that told you to order the assembly.
