WHEN SMART

REJECTIONS HELP

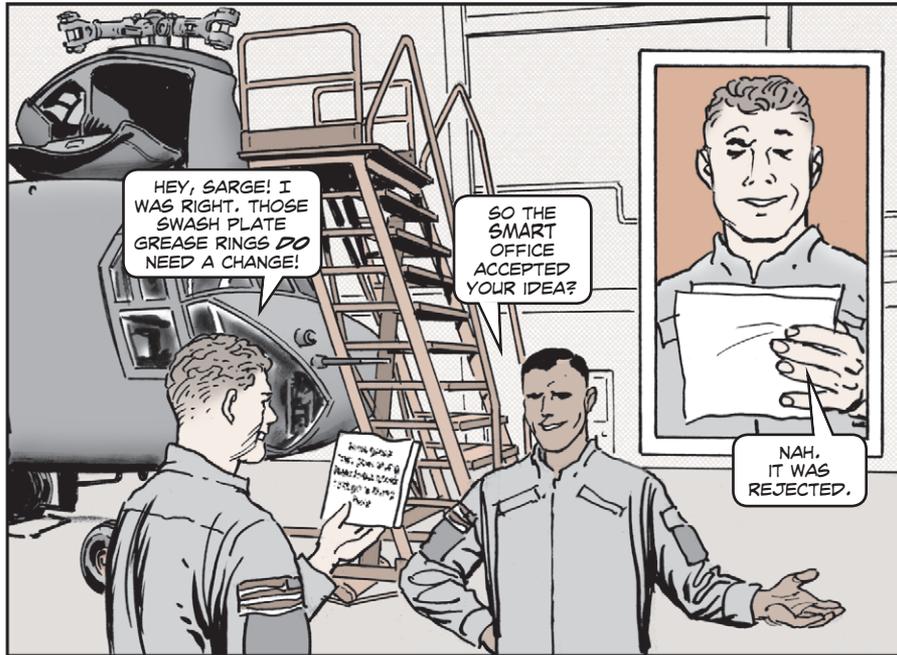
An example is the grease seal, NSN 5330-00-849-4366, for the CH-47, shown in Fig 182-2, TM 55-1520-240-23-P.

A soldier noted in his suggestion that the grease seal comes as a single piece. The seal is removed every 100 hours in order to inspect the swash plate bearings. Unfortunately, the seal can be damaged during removal. Replacement requires removal of blades, rotor head and rain shield.

The soldier's solution was to cut the replacement grease seal in half. The two equal parts could be installed with less effort at the unit.

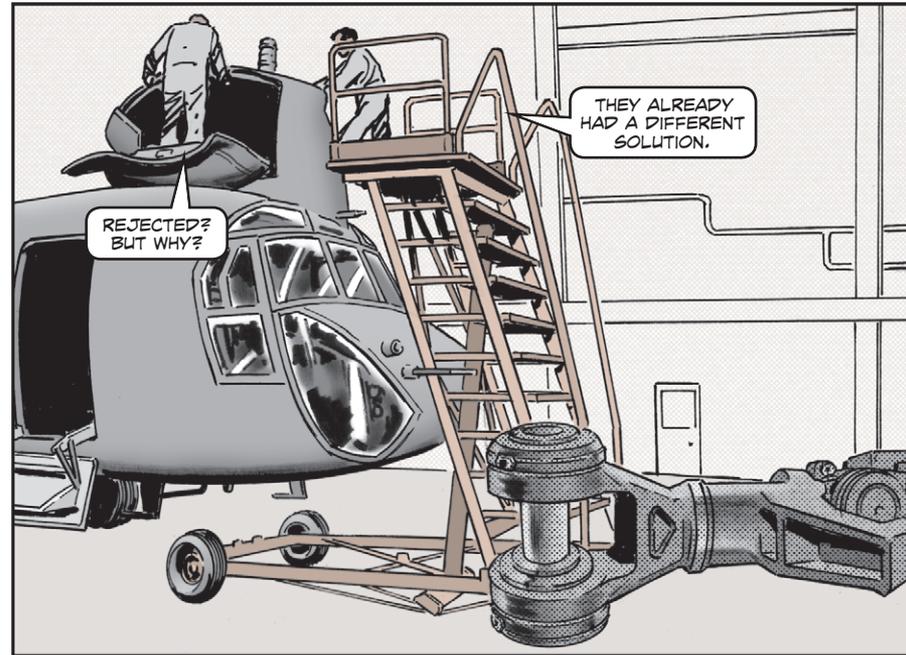
The RDECOM solution allows the cutting of the grease seal in one place. A special tool has already been designed to allow the proper cut to be made and to ensure that each seal modified is modified in the same manner.

Flight testing of this modified grease seal will begin this year.

However, the modified seal is a temporary fix. Past problems associated with both the forward and aft swash plate are driving development of new swash plates. The new swash plates will use a three-piece grease seal.
