FMTV...

LTAS HYDRAULIC BRAKE CONVERTER CONFLICT

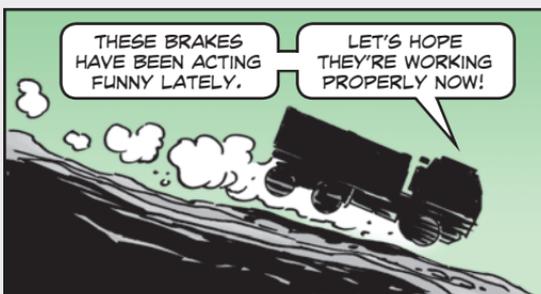
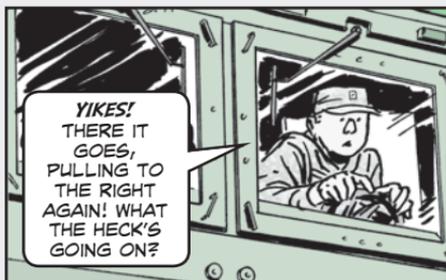
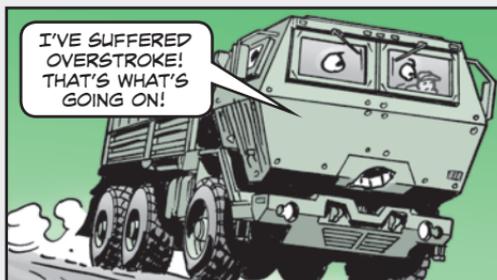
Listen up, FMTV users! IETM versions dated earlier than Sep 2010, new equipment training and TACOM SOUM 11-005 incorrectly tell maintainers to pump the brake pedal to bleed air from the brake hydraulic system. That mistake has resulted in damaged brake converters due to overstroke on LTAS FMTV trucks with a serial number before 707,449.

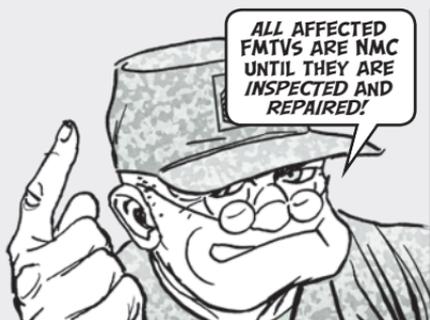
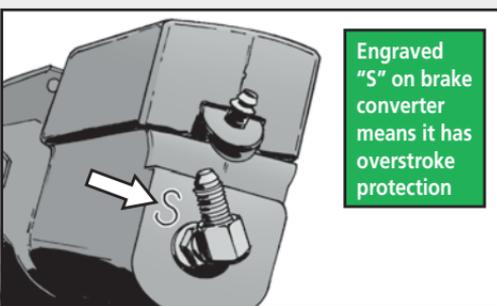
Overstroke occurs when the brake pedal is pumped when there is air or a leak in the hydraulic brake system. The resulting damage to the brake converter causes poor brake performance or sharp pulling of the FMTV left or right during heavy braking.

Units must inspect both brake converters on LTAS trucks with serial numbers lower than 707,449. See TACOM SOUM 11-013 for inspection and repair details. The instructions are pretty long, but there are detailed pictures to help you out. You can get to the guidance you need online: https://tulsa.tacom.army.mil/safety/soum/tacom_wn/sou11-013.html
