HMMWV...

Secure Alternator Wiring

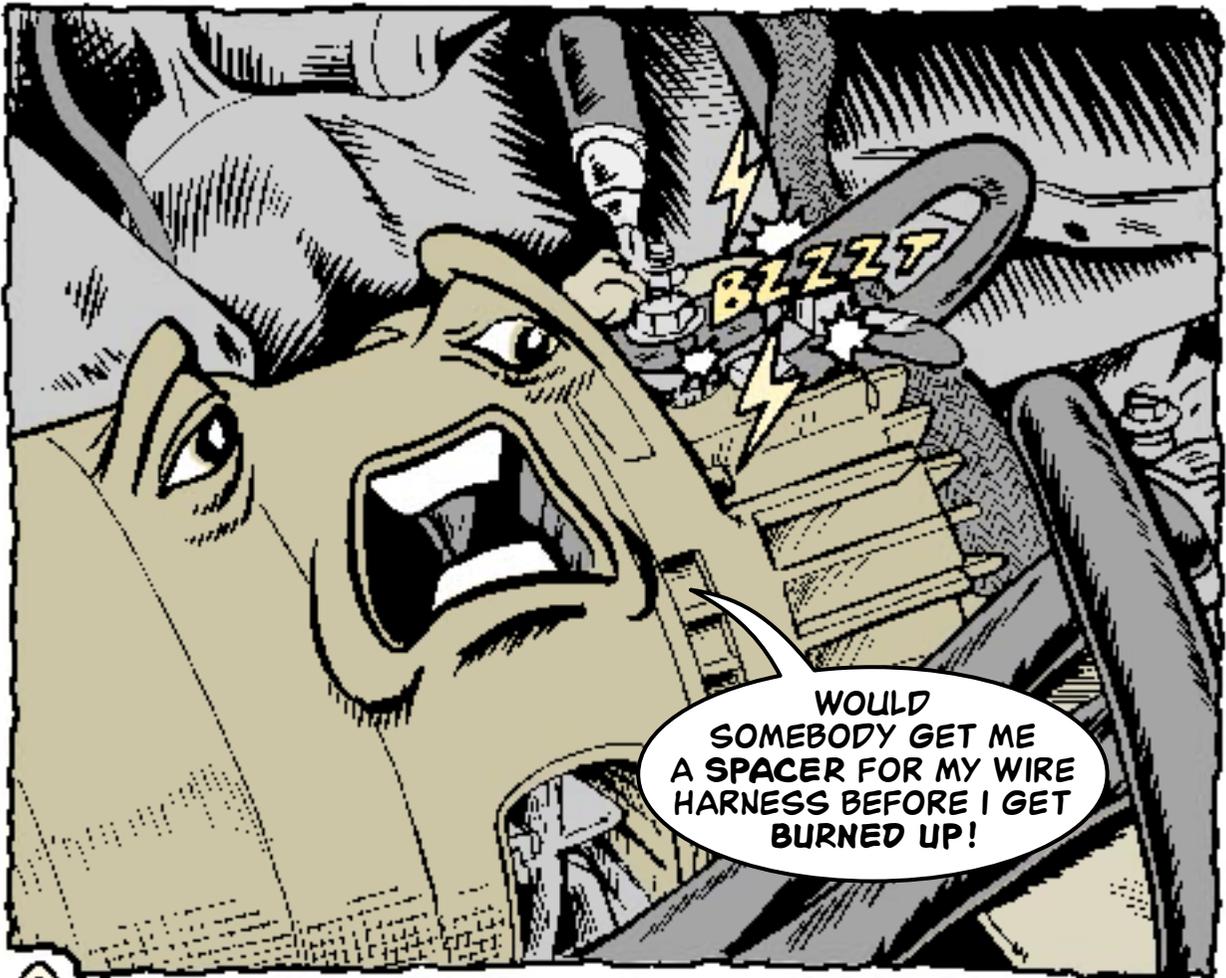
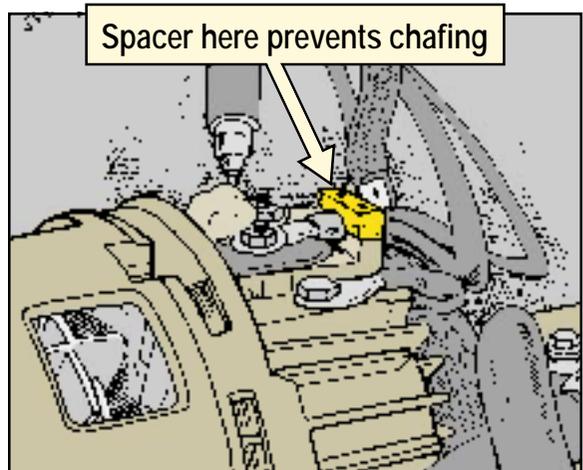
A missing spacer can be the difference between a HMMWV alternator wiring harness that works and one that's got a short.

Eyeball the rear of the 60-amp alternator in your truck to see if the harness is "trapped" under a spacer. If it is, you're good to go.

If there's no spacer, get your supply folks to order one with NSN 5365-01-289-4434. It's Item 10 in Fig 32 of TM 9-2320-280-24P-1. With the spacer in place, the harness can't chafe against the alternator body and eventually short out.

Secure the spacer with a thin spacer plate, NSN 5365-01-289-7852; washer, NSN 5310-00-721-7809; screw, NSN 5305-00-984-6212; and washer, NSN 5310-01-234-9416. They're Items 11-14 in Fig 32.
