Keep Safety on Your Side

“Better safe than sorry” is a good idea when dealing with vehicles from the M113-series family.

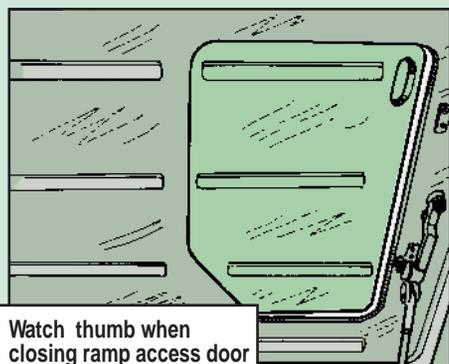
Most soldiers use their left hand to close the ramp access door when inside the vehicle. Unfortunately, that exposes their left thumb to danger.

If the thumb is extended, it may stick out far enough to get caught between the door and the door frame.

So, add the following WARNING to Page 2-142 of TM 9-2350-261-10 and Page 2-159 of TM 9-2350-277-10:

Use of the left hand to grasp and close the ramp access door will expose thumb to being extended beyond the door’s edge leading to possible amputation when the door is pulled closed. When using left hand, use only the center of the handhold and be aware of the thumb’s position.

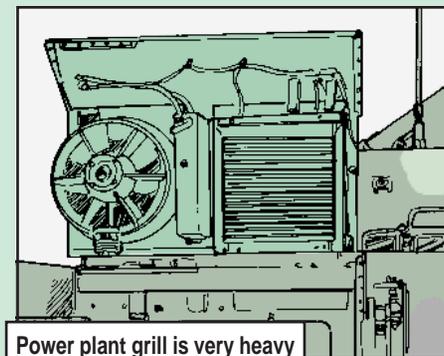
You must use extra care when you remove or replace the power plant grill. It’s very heavy, so use the proper lifting equipment at all times.

Add the following WARNING to Page 5-1 of TM 9-2350-261-20-1 and Page 7-51 of TM 9-2350-277-20-3:

When removing and installing the Power Plant Grill, you must be aware that the grill assembly will swing when the screws are removed. To avoid injury, do not stand in front of or behind the grill assembly.

Use chain and lifting device capable of lifting and holding 2,000 pounds (908 kg) securely. Inspect each and be sure your chain and lifting device are in good working order and are not damaged in any way. Do not use damaged lifting devices. They can fail with load. Soldiers can be killed or injured. Remember the grill and access cover are very heavy. Use extreme caution when lifting, blocking and lowering the assembly. Allowing the assembly to fall could cause death or injury.
