Grille Removal Made Easy

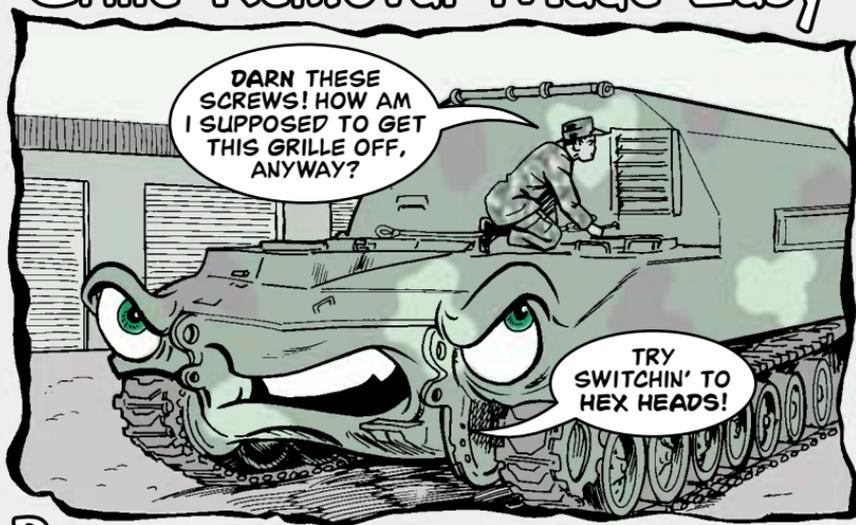
Drivers, the personnel ventilator on your M992A2 ammo carrier has an important job. It pulls in cool, outside air to help keep you comfortable and vents dangerous fumes from the crew compartment—like when the automatic fire extinguisher system (AFES) is activated.

That's why it's important to keep dirt, leaves and other debris cleaned out of the ventilator exhaust. If the exhaust is clogged, there's no airflow and your vehicle is NMC.

At least monthly, remove the grille covering the exhaust and clean out any debris that has collected. You may have some problems with the grille's rear socket head screws, though. Because the screw sits just under the tow cable, you'll have a hard time getting your socket wrench in place to remove them.

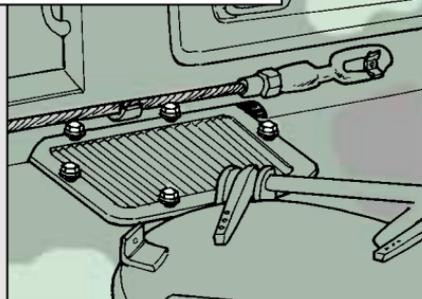
Replace socket head screws with hex head screws

Once the grille is finally off, save yourself aggravation next time by replacing the socket head screws with regular hex head screws, NSN 5305-00-719-5219. You can remove them without having to move the tow cable.
