MLRS Carrier...

SMOKE OUT THE PROBLEM

Tap Your Way Out of Trouble

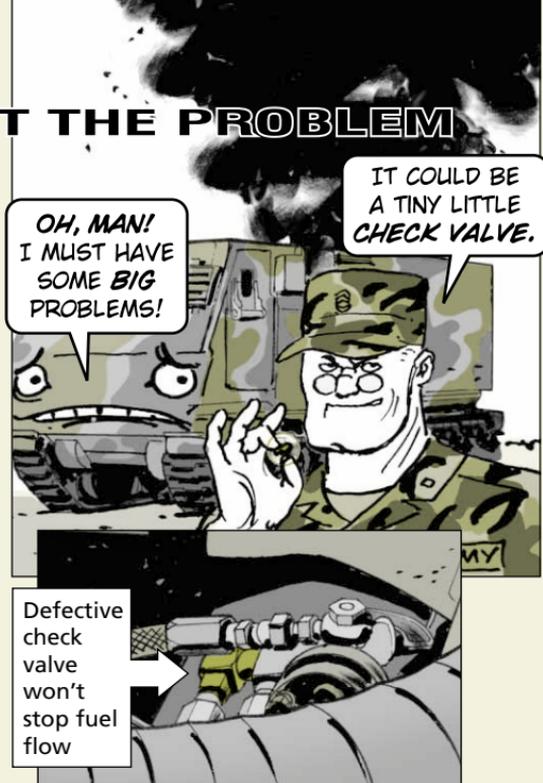
The problem could be as simple as a defective check valve on the cold start pump. This valve, NSN 4820-01-297-8296, is supposed to prevent fuel flow unless the COLD START switch is on.

If the check valve is bad, fuel flows all the time and your vehicle can't burn it all. Heavy smoke and a damaged cold start pump are the results.

Call in your mechanic to check it out.

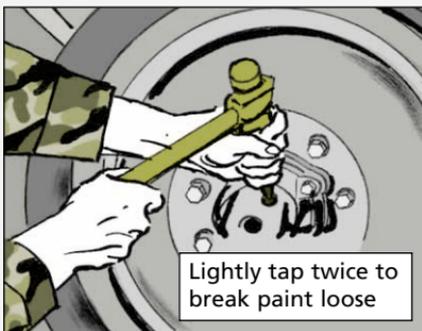
To get each hub off, you must first remove the two retaining screws. Problem is, the screws have often been painted in place with CARC.

If that's the case, those screws are almost impossible to remove. When you try, the heads of the screws get chewed up and your mechanic has to get involved.

Tap the head of each screw twice with a hammer. Lightly now—you don't want to crack the hub.

Next, put a cross-tip screwdriver on each screw and lightly tap its handle twice.

That may break loose the paint holding the screws in place and let you screw them out easily.
