M109A2-A5 SP Howitzers...

## PROTECT LOCK WITH LININGS

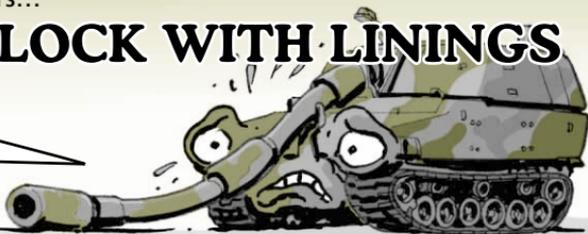
OH, MY ACHIN'  
SCHNOZZOLA! I  
NEED NEW TRAVEL  
LOCK LININGS!

**M**echanics, missing or worn-out travel lock friction linings will do a lot of damage to the M109 howitzer's cannon tube. Linings are easier and cheaper to replace than cannon tubes.

The linings cushion the tube when it's in travel lock, keeping metal from banging and scraping on metal.

Prevent tube damage by replacing worn or missing linings. You'll need two linings, NSN 2530-01-060-7229, for each travel lock.

Remove the old linings and adhesive residue with a putty knife and dry cleaning solvent. After the surface dries, apply new adhesive, NSN 8040-00-926-9133, to the replacement linings and install them. Order the adhesive on a DD form 1348-6 and put "NSN not on AMDF" in the REMARKS block.

Leave the travel lock open for one hour until the adhesive dries.

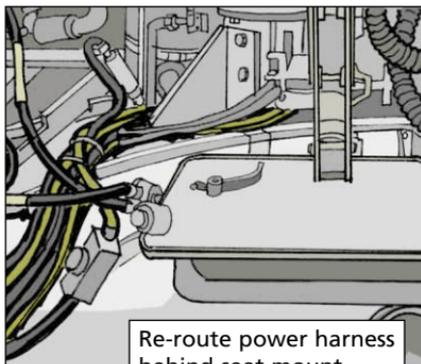
**G**ot a short in the turret power harness of your M109 howitzer? Chances are the commander's seat is to blame.

When the seat is folded down, the wiring harness can get pinched between the seat mount and the turret wall. If the insulation gets cut, your howitzer can end up with a short—and you end up with no power to the turret.

So eyeball the harness to make sure it's out of the way and won't get pinched. If it's in harm's way, let your mechanic know so he can re-route the harness to clear the seat mount.
