HALT HATCH HEADACHES

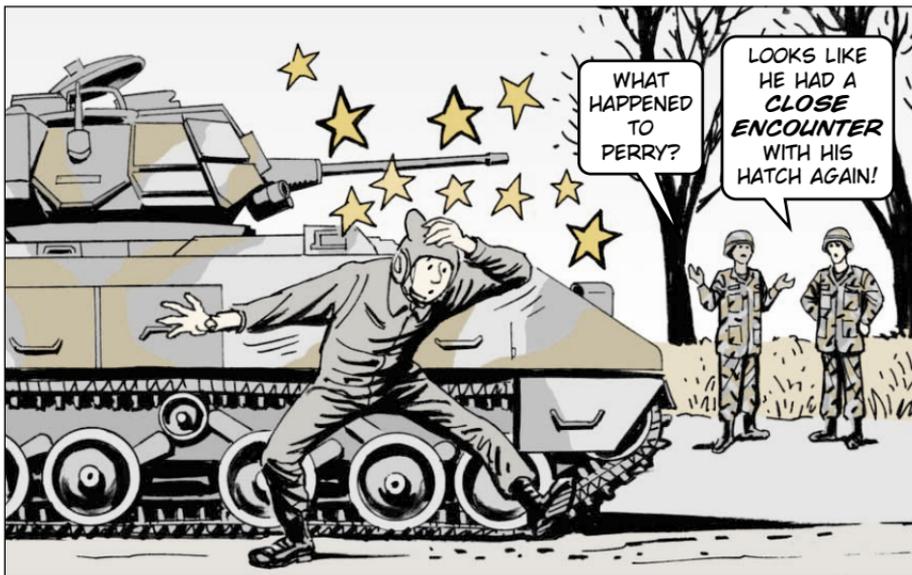
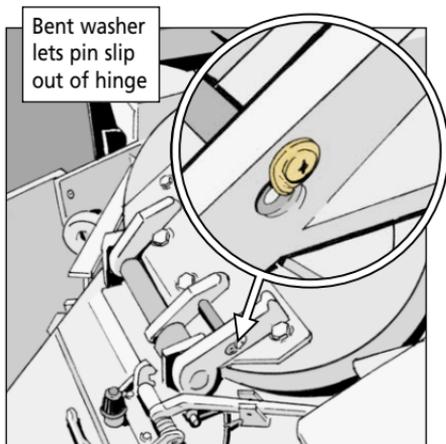
The gunner's hatch up armor modification kit uses a washer, NSN 5310-01-274-3255, to secure the hinge bracket hold-up pin. The washer is a bit flimsy, so it often gets bent or broken off.

A bent or lost washer lets the hold-up pin, NSN 5315-01-440-0269, slip out of the hinge. With nothing to grab, the latch mechanism slips loose and—CRASH—down comes the hatch.

Eyeball that washer right now. If it's bent, broken or missing, replace it with a new and improved washer, NSN 5310-01-460-8846. The new washer is twice as thick as the old one.

Unless the hinge screw, NSN 5305-00-988-1723, is damaged during removal, you can reuse it to secure the new washer.
