M119A1 Towed Howitzer...

# PREVENT CRUSHED TAILLIGHTS

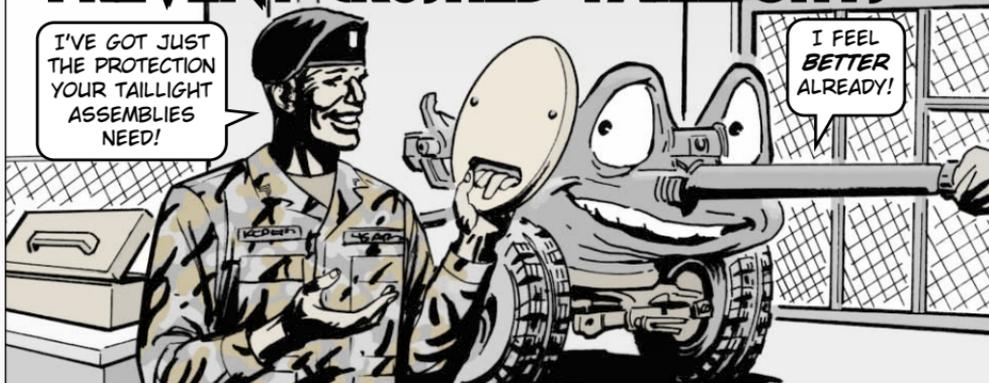
M119A1 howitzer taillight assemblies, NSN 6220-01-369-2920, get crushed when they're stored in the back of a HMMWV.

When it's time to reinstall them on your howitzer, they're badly mangled and often don't work. Nobody's happy when a ruined assembly has to be replaced. They cost more than \$670!

We protect our taillight assemblies with a wooden plate. Here's how to make and use it:

1. Cut out two 10-in diameter circles from a sheet of 3/4-in thick plywood.
2. Secure one circle on top of the other using three 1-in long drywall screws.
3. Cut an oval hole in the top of the circles to use as a handle. The hole should be approximately 4 1/2 inches long by 1 1/2 inches wide.
4. Slip the plate inside the opening of the taillight assembly. Tighten the taillight clamp screws to hold the plate securely in place.

The plate strengthens the taillight assembly and keeps it from being bent or crushed.

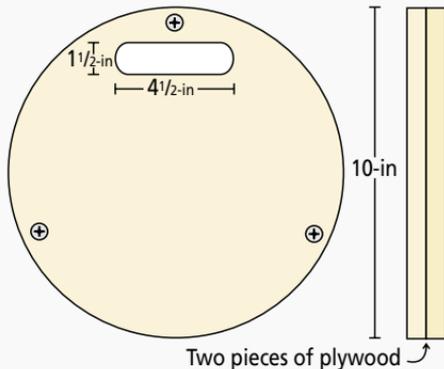
Two pieces of plywood

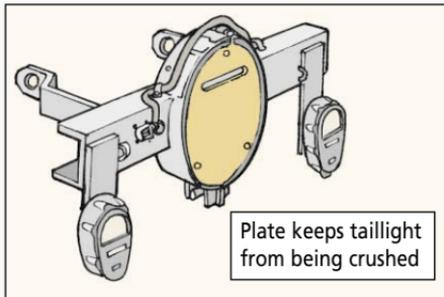
Plate keeps taillight from being crushed
