NO BACKWARD? WIRES ON GENERATORS

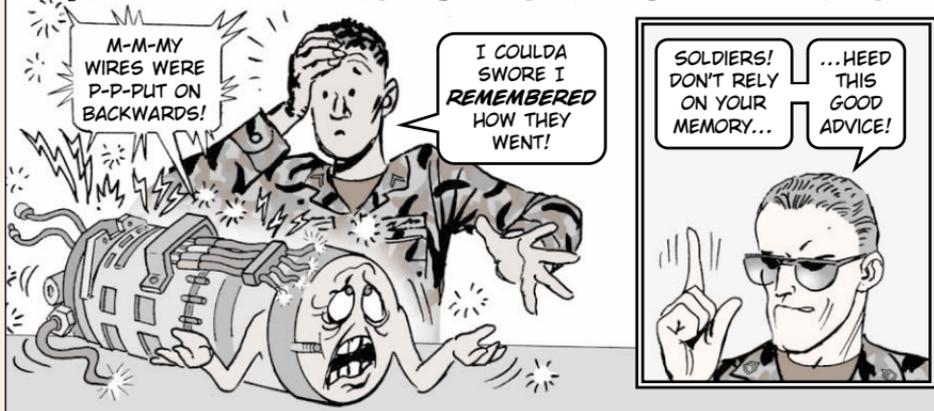
We have a lot of problems with wires being put on backwards after maintenance on the AH-64 No. 1 and No. 2 generators.

And backward wires lead to fried generators.

Our idea is to use an assortment of different colored heat-shrink tubing with stamped stud numbers around the wire leads to avoid the wrong hookup.

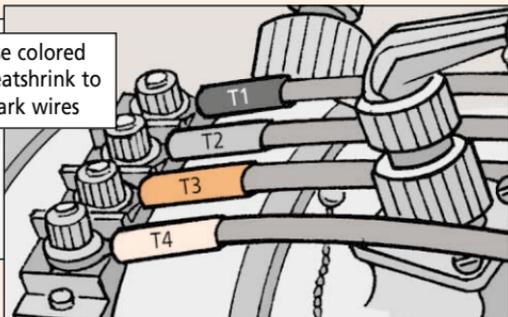
Use colored heatshrink to mark wires

Wire	Tubing
T1	Black
T2	Blue
T3	Red
T4	Yellow
