LOOK AT FIRE EXTINGUISHER VALVE

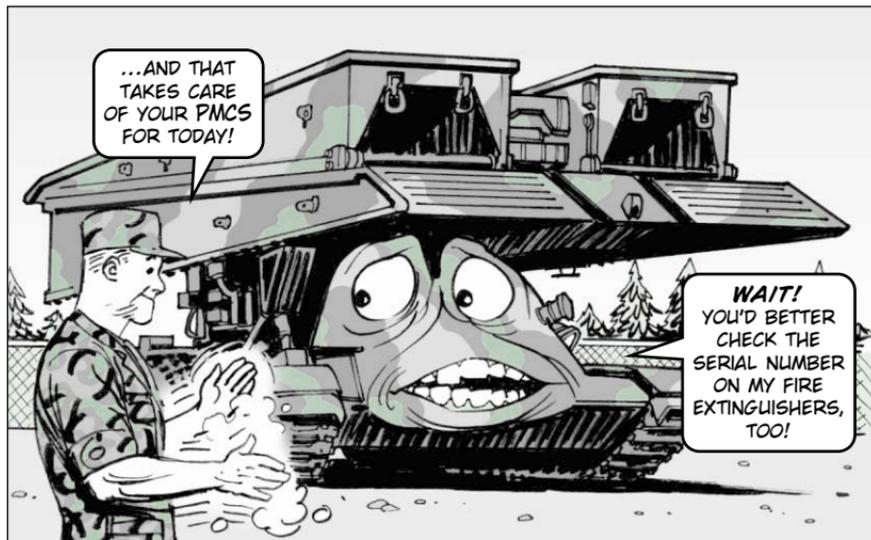
Crews, check the valve on the 5-lb fixed fire extinguisher assembly in the crew compartment of your M104 Wolverine. If the valve has one of these three serial numbers—1092, 1208, or 1212—get the extinguisher replaced now!

The Santa Barbara Dual Spectrum valves originally used on these fire extinguishers were defective. Tests showed that the valves stopped working after several automatic discharges and could then only be discharged manually.

DUAL SPECTRUM®			
SENSING AND SUPPRESSION SYSTEMS					
FIRE EXTINGUISHER VALVE					
P/N	283281-0002	MFG	61423	S/N	1092
CUSTOMER P/N	19207 ASSY - 12324276				
SERVICE	HALON 1301 & N2		OPER PRESS.	750	PSI
CONT NSN			SBD5 CAGE 05BU0 U.S. PAT. NO. 4,579,315		
SANTA BARBARA DUAL SPECTRUM 163 AERO CAMINO GOLETA, CALIFORNIA 93117

Take a close look at the serial number on the fire extinguisher valve. If you find one of the missing serial numbers, contact your local TACOM LAR or the Wolverine program manager's office (DSN 786-5522/5557 or (586) 574-5522/5557) for turn-in information.
