DISPLAY SCREEN PROTECTION

There is a mountain of hand-held terminal units (HTU), AN/PSG-9(V)1 and (V)2, at the manufacturer for replacement of cracked display screens.

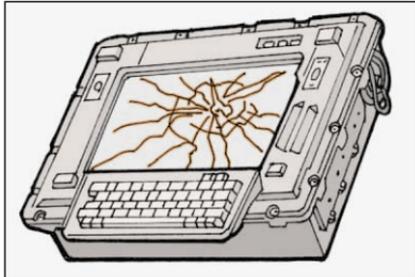
WHADDAYA
MEAN, *MY*
UNIT'S GOTTA
PAY TO FIX
ALL THESE
DISPLAY
SCREENS?!?

Protect those screens by putting on reinforcement modification kit, NSN 5895-01-483-2434. The kit includes an aluminum plate, two pieces of Velcro and installation instructions.
