DON'T CUT THAT FUEL HOSE!

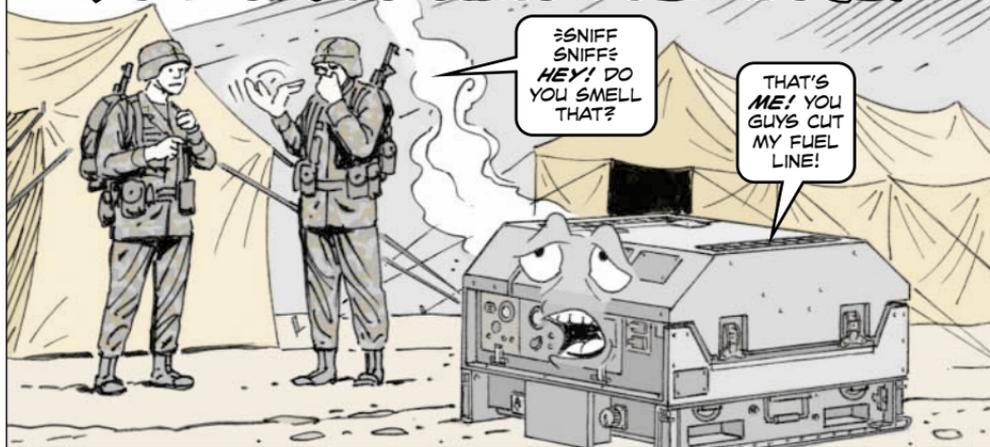
Holes are showing up in the fuel hoses because the pull/start rope of the recoil starter assembly is rubbing against the hose and cutting away some of the covering. This is happening between the primary fuel pump and the fuel filter assembly.

It seems the auxiliary fuel hose forces the primary fuel hose down into the pull/start rope. If you frequently start your generator manually, you will eventually cut a hole in the fuel hose.

1. Remove the auxiliary fuel hose before you manually start the generator.
2. After the generator starts, put the auxiliary fuel hose back in the same spot.
3. Check the primary fuel hose to make sure no rubbed spots are showing up. If your fuel hose is already cut or damaged, it must be replaced!
