AH-64A/D...

SNAKE THE DRAIN HOLE

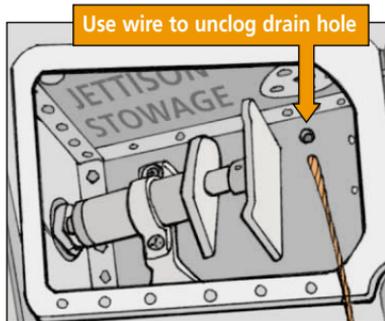
Standing water inside the canopy jettison handle access door (T50) of your Apache means you need a rotor rooter job, repairers.

The canopy jettison handle sits forward of the copilot gunner window (CPG) under a quick release panel for the ground crew to blow off the side panels in an emergency evacuation.

Just because it's out of sight doesn't mean you should put it out of mind. If you do, and water backs up into the canopy housing because of a clogged drain hole, you can bet your bottom dollar that the canopy jettison system will short out. Plus, water can also seep into the forward avionics bay and cause damage to components.

So when you perform your 10-hour/14-day inspection like it says in TM 1-1520-238-PMS, eyeball the drain hole inside the canopy jettison pin storage area to make sure it's not filled with water.

To unclog the drain hole, use a 6-ft, long, 1/16-in diameter wire. Attach a "Remove Before Flight" streamer, NSN 8345-00-673-9992, and swedge, NSN 4030-00-960-1654. Smooth out all the burrs with a piece of crocus cloth and lightly coat the wire tip with RTV and let dry. Snake the drain hole with the wire to get the crud out. When the drain is clear, remove the wire to prevent a FOD problem.
