# OUT OF YOUR DEPTH

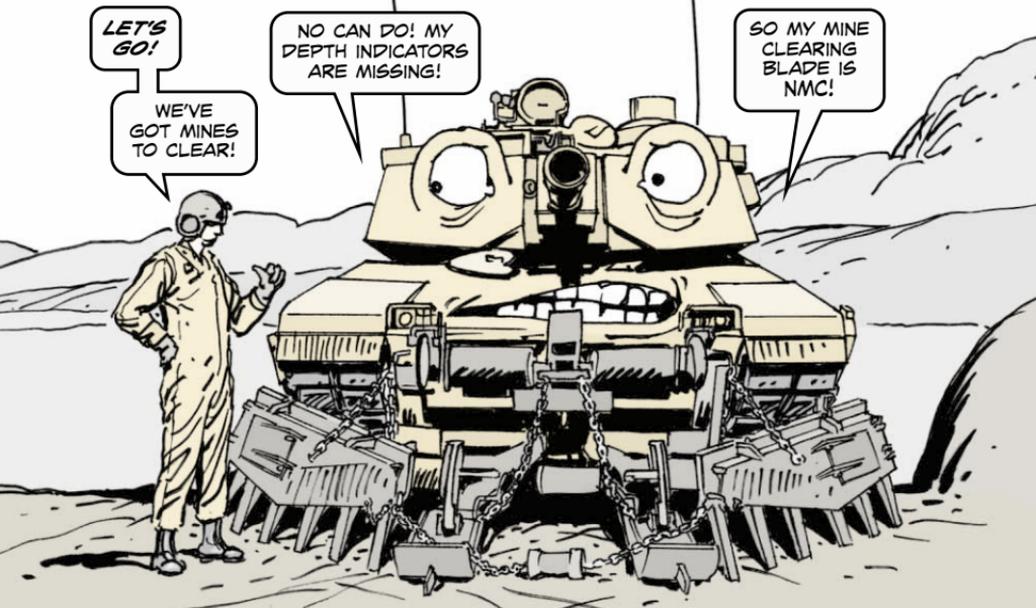
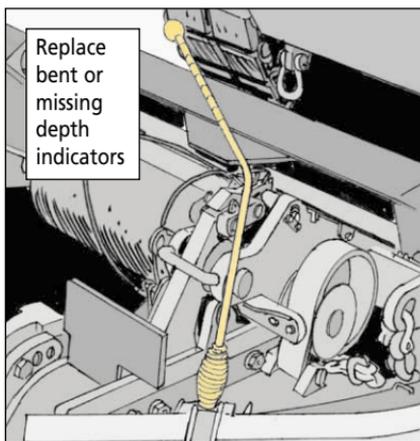
**W**hen taking your M1-series tank's mine clearing blade through brushy areas, the depth indicators take a beating. Sometimes the beating's bad enough to bend or even break the indicators.

A broken or missing indicator deadlines your mine blade. A bent one does not. But it still makes it hard to tell how deep you're plowing. When it comes to dealing with mines, you never want to be out of your depth!

There's no NSN for a replacement shaft. Instead, you'll have to order a complete depth indicator kit, NSN 2590-01-462-3313. The kit costs \$109, but includes 2 depth indicators and all the hardware needed for installation. Instructions for installing the kit are on Page 2-132 of TM 9-2590-509-23&P.
