THANKS FOR THE MEMORIES

Once a year, cowboy, you need to say adios to the 3.6-volt, lithium memory battery, NSN 6135-01-301-8776, in your precision light-weight GPS receiver (PLGR).

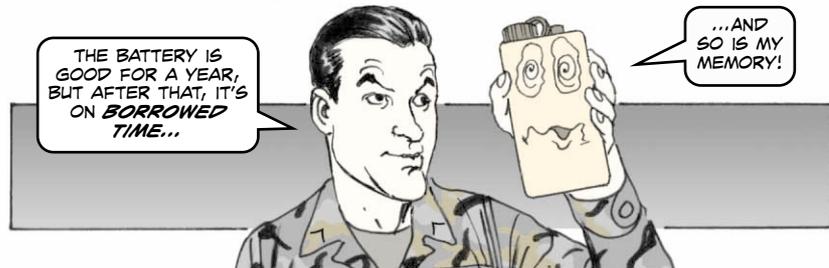
Don't wait to replace the battery until you get the low memory battery warning. Depending on how often you use the PLGR, that warning might come and go without your seeing it. If the battery is a year old, this is your warning!

Also, be aware that a dead memory battery might leak. If it does, it could damage the battery compartment and other areas of the PLGR.

Some leaks happen when you screw the memory battery cover back on. The cover's coiled spring punctures the battery. Make sure the spring has not been twisted out of alignment. If it has, get it back in place before you put the cover back on.

When you replace the 3.6-volt, lithium battery don't be fooled into using an AA battery. The 1.5-volt, L91, lithium battery, NSN 6135-01-333-6101, likes to impersonate the memory battery. It will fit into the compartment, but it lacks the power to hold on to the stored data.
