TURN THE TABLES

You need to turn the tables on corrosion for the HEMTT crane's turntable bearing, drivers.

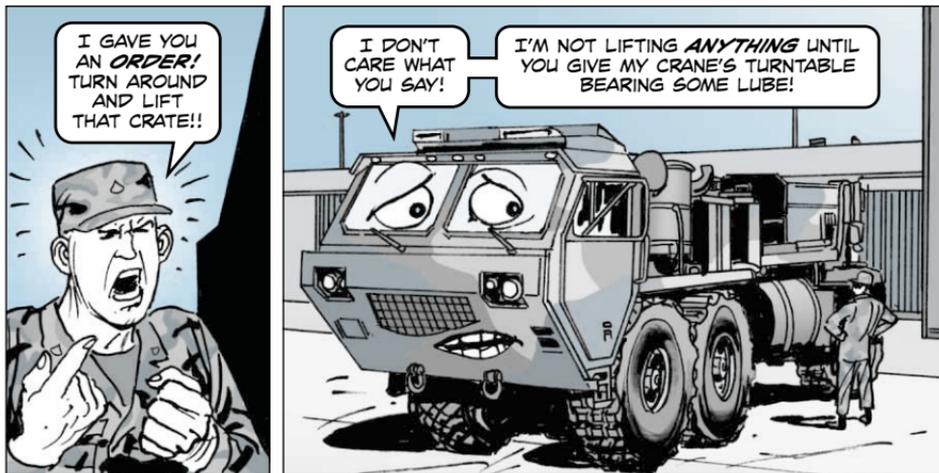
That bearing is often missed because you can't see the grease fitting unless the mast is raised. Without lube, the bearing goes dry and burns up. A new bearing will cost your unit between \$1,000 and \$2,100 depending on the vehicle.

So semiannually, or every 500 operating hours, raise the mast and lube the bearing with GAA. Here's how:

1. Find the grease fitting and pump in GAA until you see new grease coming out of the seal. Wipe off the excess.
2. Rotate the crane 90° and repeat step 1. Continue rotating and lubing until the turntable has been lubed at the 12, 3, 6 and 9 o'clock positions. Then completely rotate the turntable 360° to spread the lube.
