Replace Worn Strap

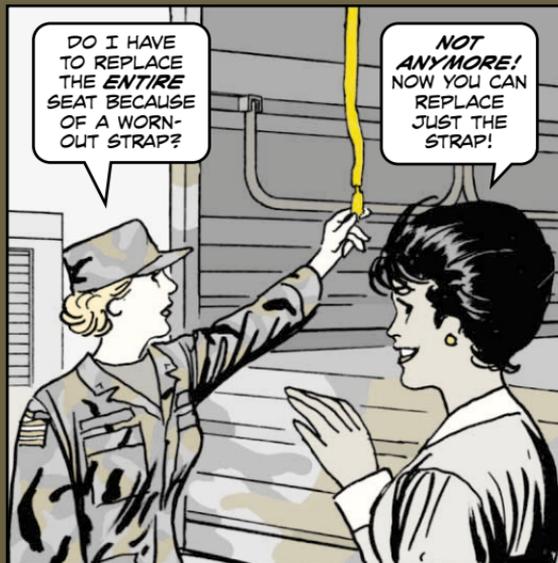
Desert conditions have turned the original troop seat stowage straps on some FMTVs into rags.

If the straps on your trucks show signs of brittleness, cuts, tears or shredding, don't go looking for the replacement information in your truck's -24P.

What will be added to Fig 232 in both FMTV -24Ps is a belt, NSN 2540-01-438-5919. It's 1½ inches wide with a quick-disconnect fastener. It must be riveted to the troop seat.

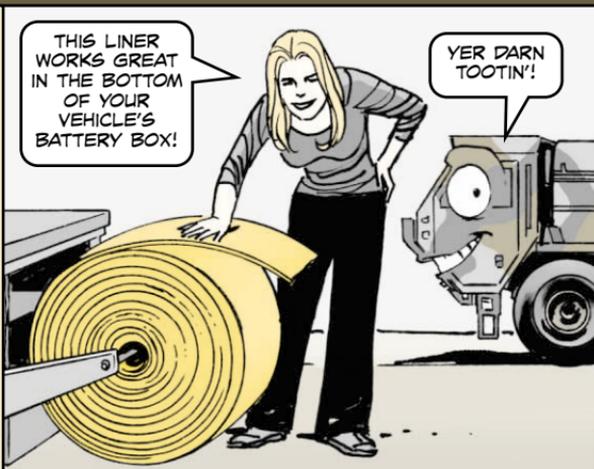
BATTERY BOX LINER

Battery box liner works finer than anything else for absorbing battery acid in your vehicle's battery box.

The liner not only absorbs battery acid, but neutralizes it as well.

Get a roll of 1/4-in thick liner with NSN 6160-01-389-1966 and cut to the dimensions you need to line a vehicle's battery box.
